Adaptation of historic buildings for disabled people

Project UNINET: University Network for Cultural Heritage – Integrated Protection, Management and Use

Lublin University of Technology

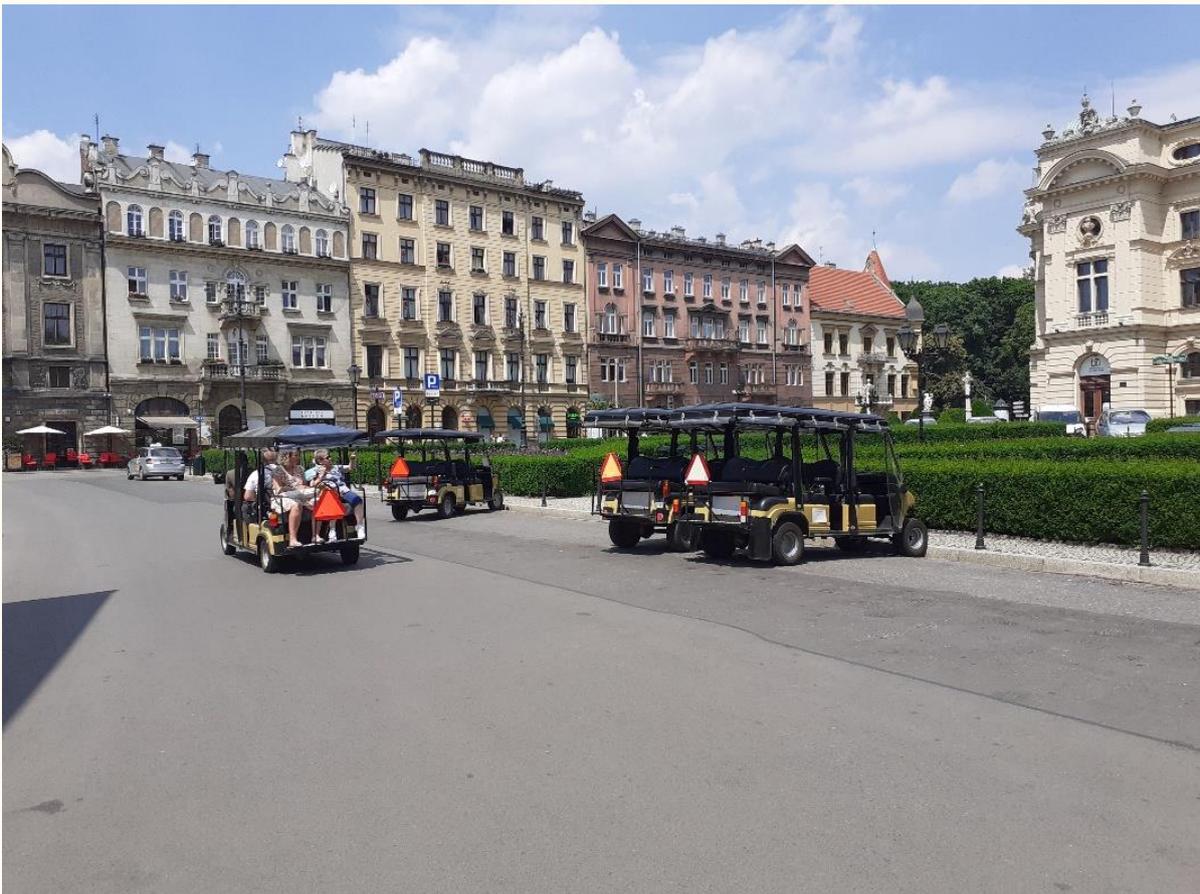
FIG. I Parking of electric trolleys in the Old Town in Cracow, near the access from the train station

The electric trolley service is licensed by the Cracow City Hall. The number of vehicles, their size and colors of the roof are checked. This service is paid, but it undoubtedly increases accessibility to historic attractions of the city and allows to visit the entire complex, even for people with very limited mobility. All in all, there are many people willing to use electric vehicles.

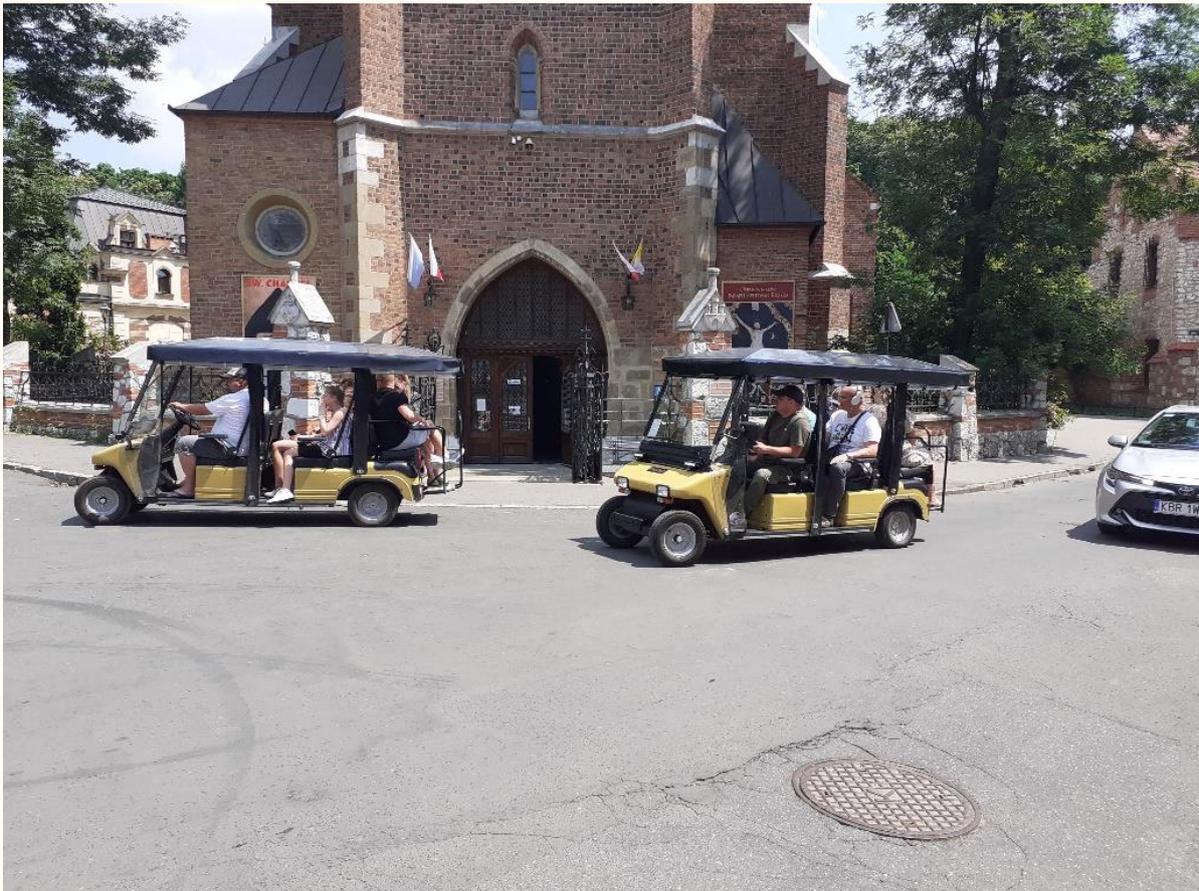
FIG. 2 Traveling with electric trolleys around the Old Town in Cracow

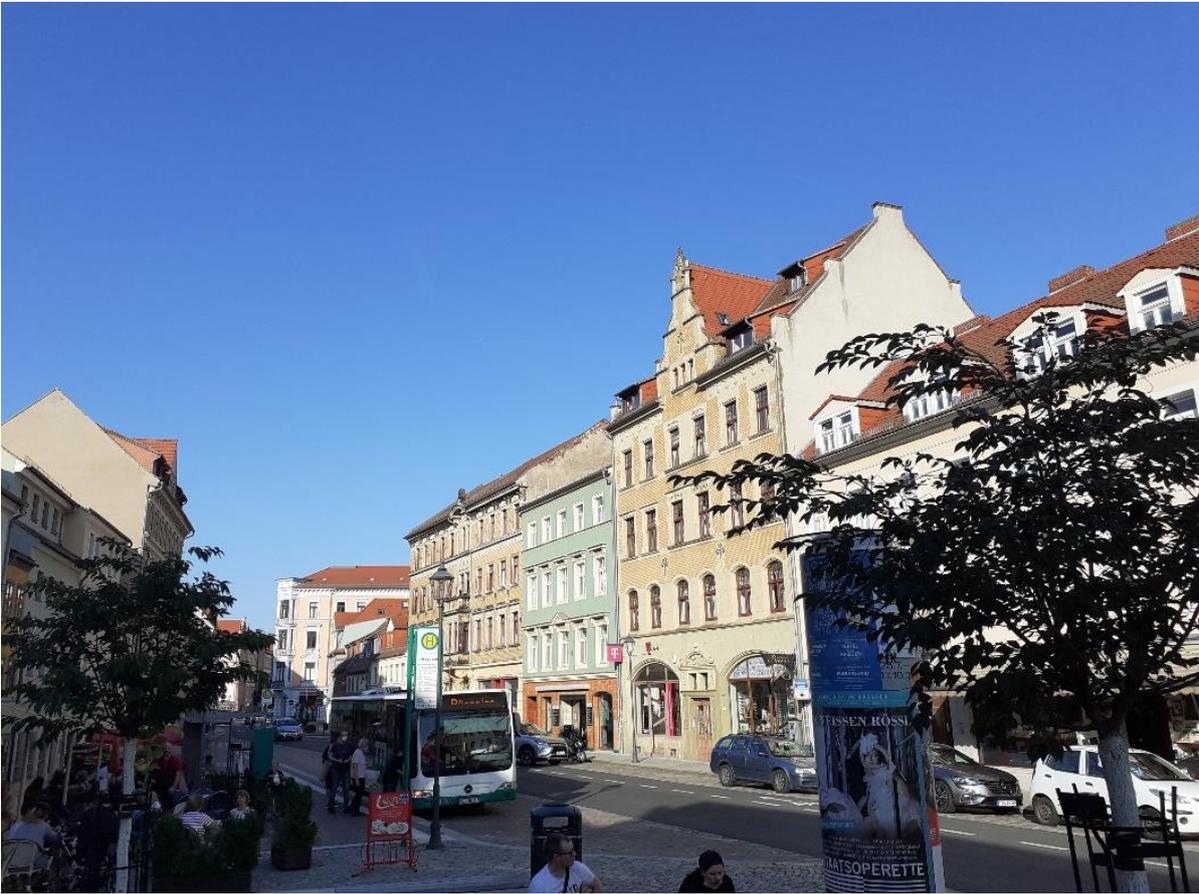
The bus runs all the time between the Porcelain Museum, which can be easily reached on foot or by car, and the castle hill. The bus takes passengers directly to the courtyard in front of the cathedral, from where it is also very close to several hotels and restaurants.

FIG. 3 A bus on the castle hill in Meissen which runs only between the main historic attractions of the city

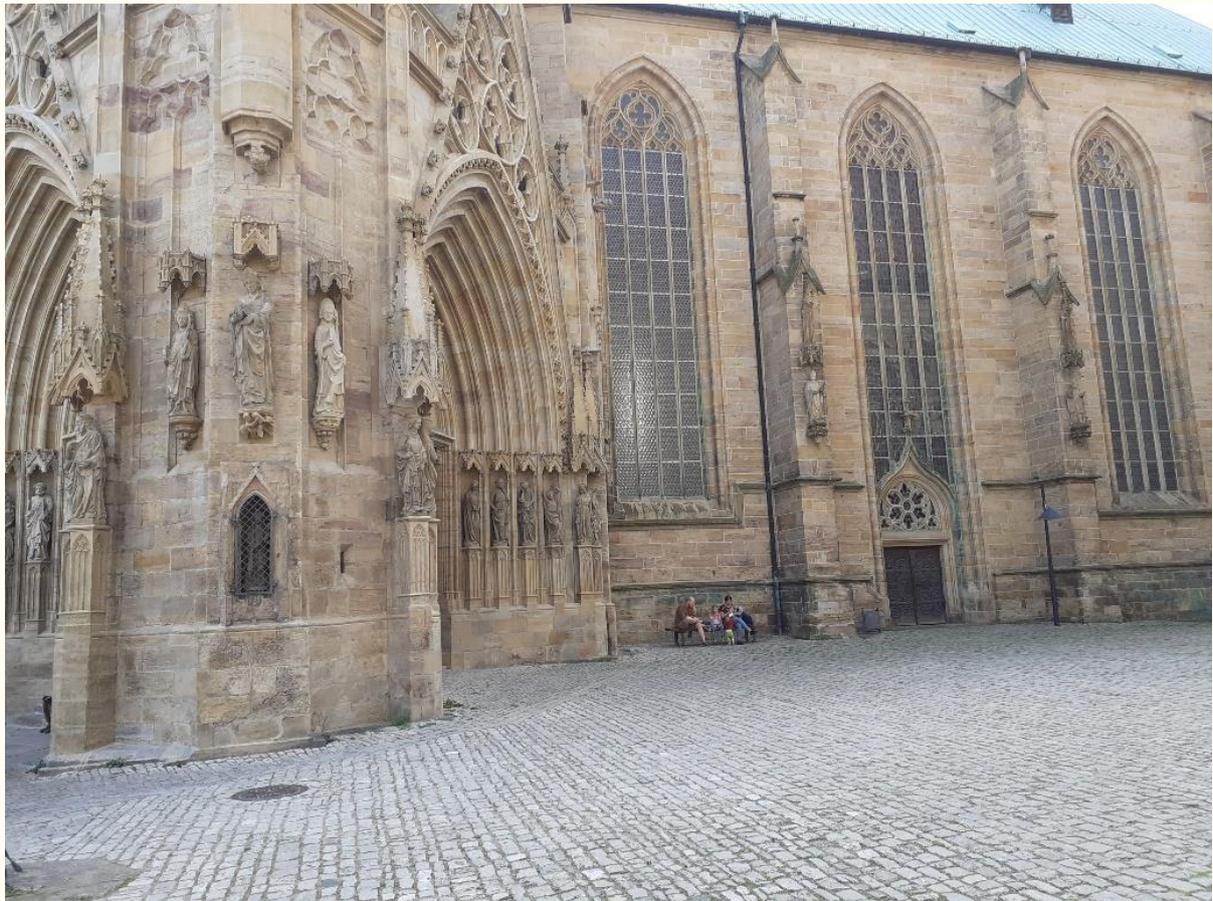
FIG. 4 Erfurt Cathedral - symbol of the capital of Thuringia

Several dozen meters long stairs lead to the main entrance, impossible for people with limited mobility. It would also be difficult to install technical devices aiding the movement of people with disabilities on these stairs. Therefore, for these people there is a technical road that can be driven directly to one of the entrances. At the entrance, there is a special parking space where people with limited mobility may park their car.

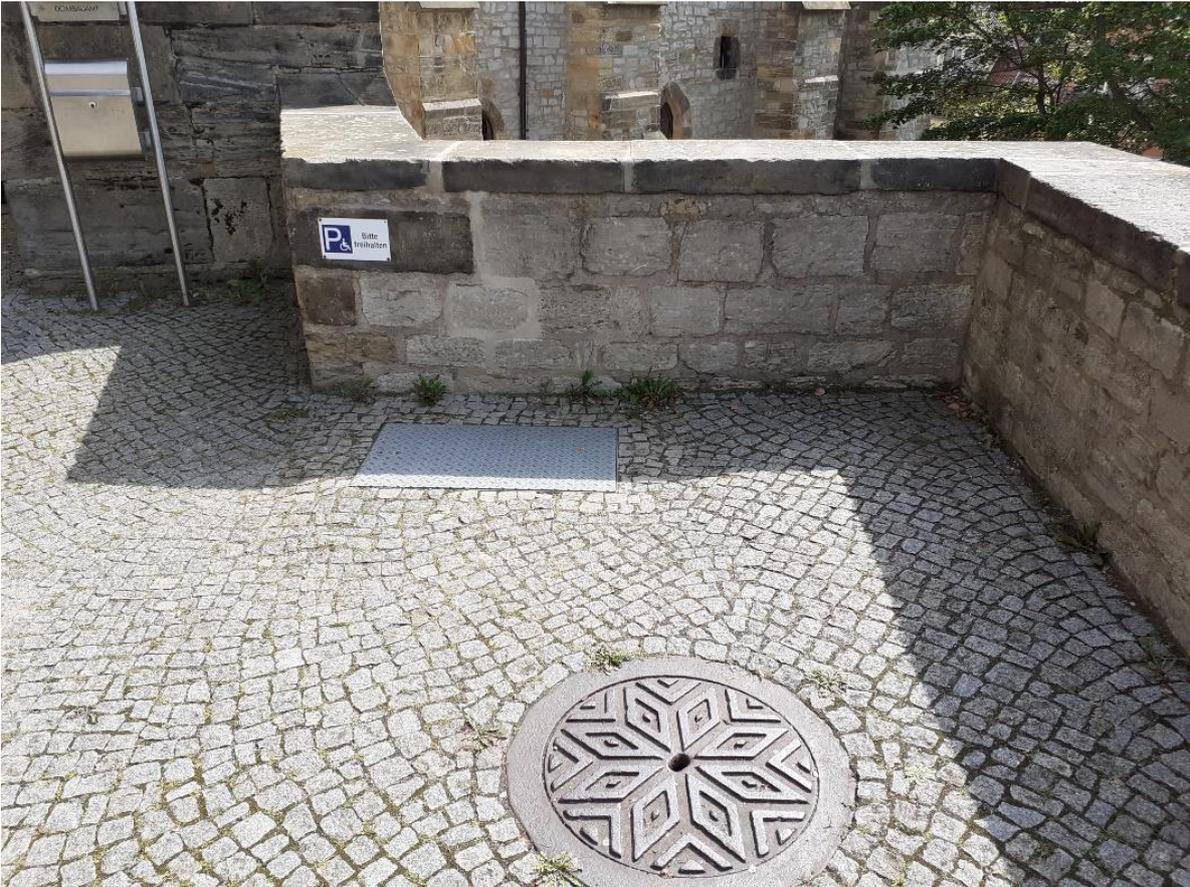
FIG. 5 A parking space placed directly next to one of the entrances to the cathedral

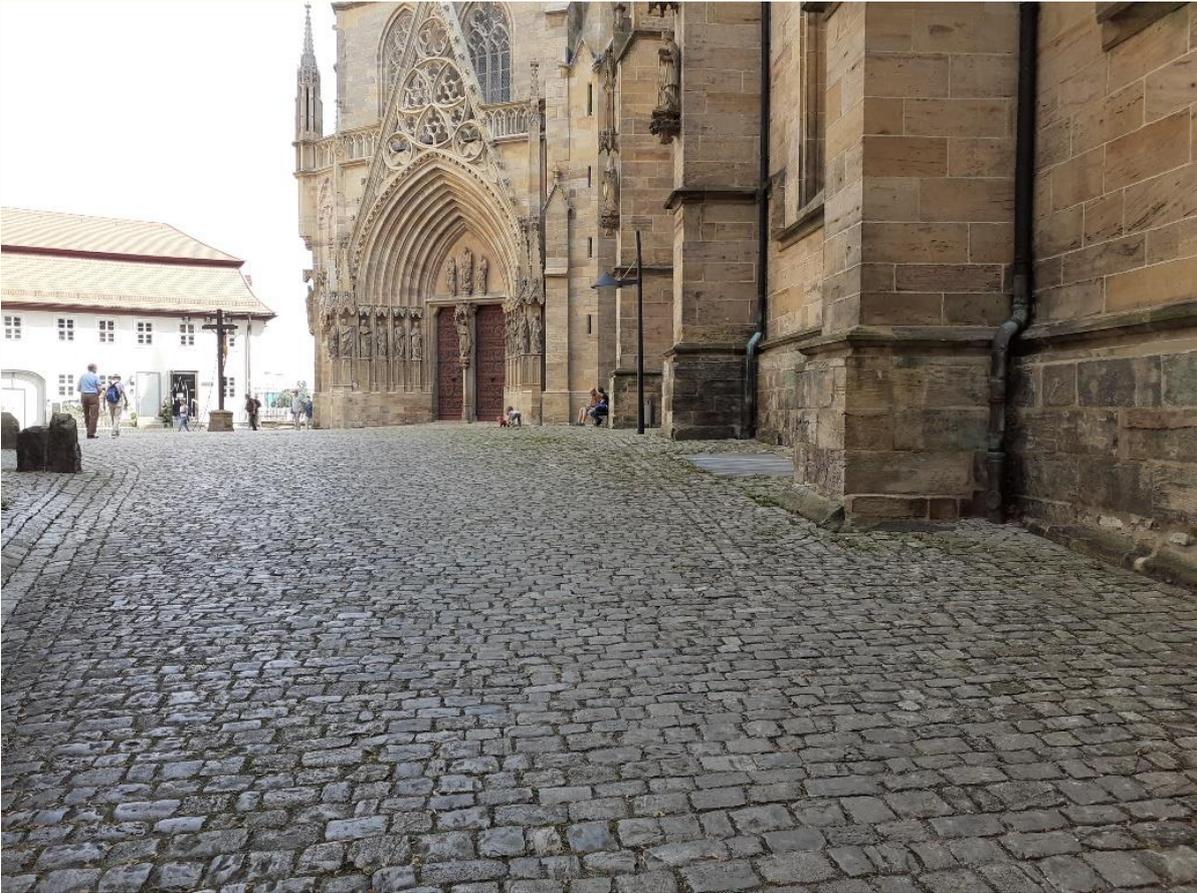
The possibility of driving directly to the entrance to the cathedral is a very helpful solution, also due to the type of surface on the cathedral hill. The entire area around the church is covered with historic cobblestones. Moving on such a surface is very difficult, especially for people in wheelchairs or other mobility restrictions.

FIG. 6 Cobblestone pavement covering the courtyards surrounding the cathedral in Erfurt

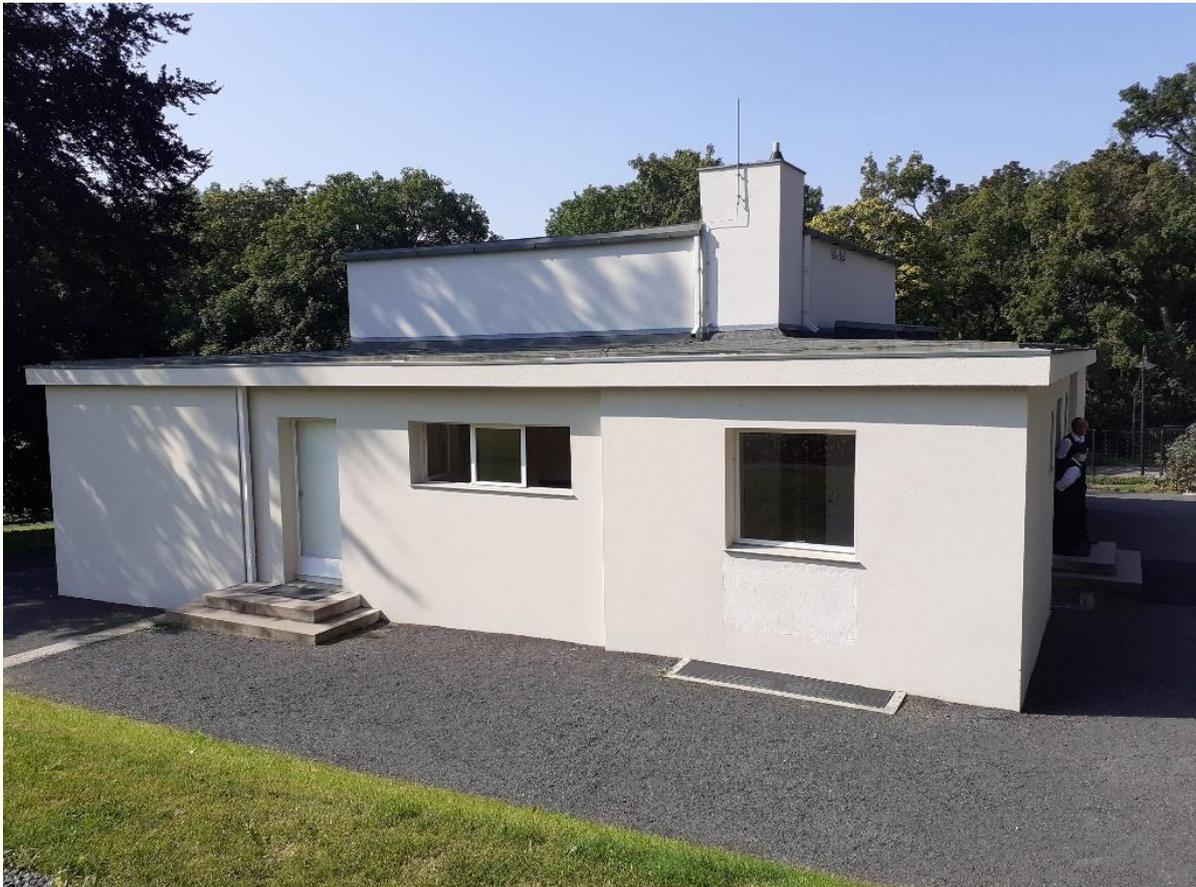
FIG. 7 Haus am Horn - the first demonstration Bauhaus residential building

A small, one-story building was erected on the outskirts of a huge landscape park, occupying nearly 50 hectares. The building is located at the end of a long cobbled street that must be reached after more than a kilometer. So getting there on foot is long and difficult. For people with limited mobility, access by car is the only solution.

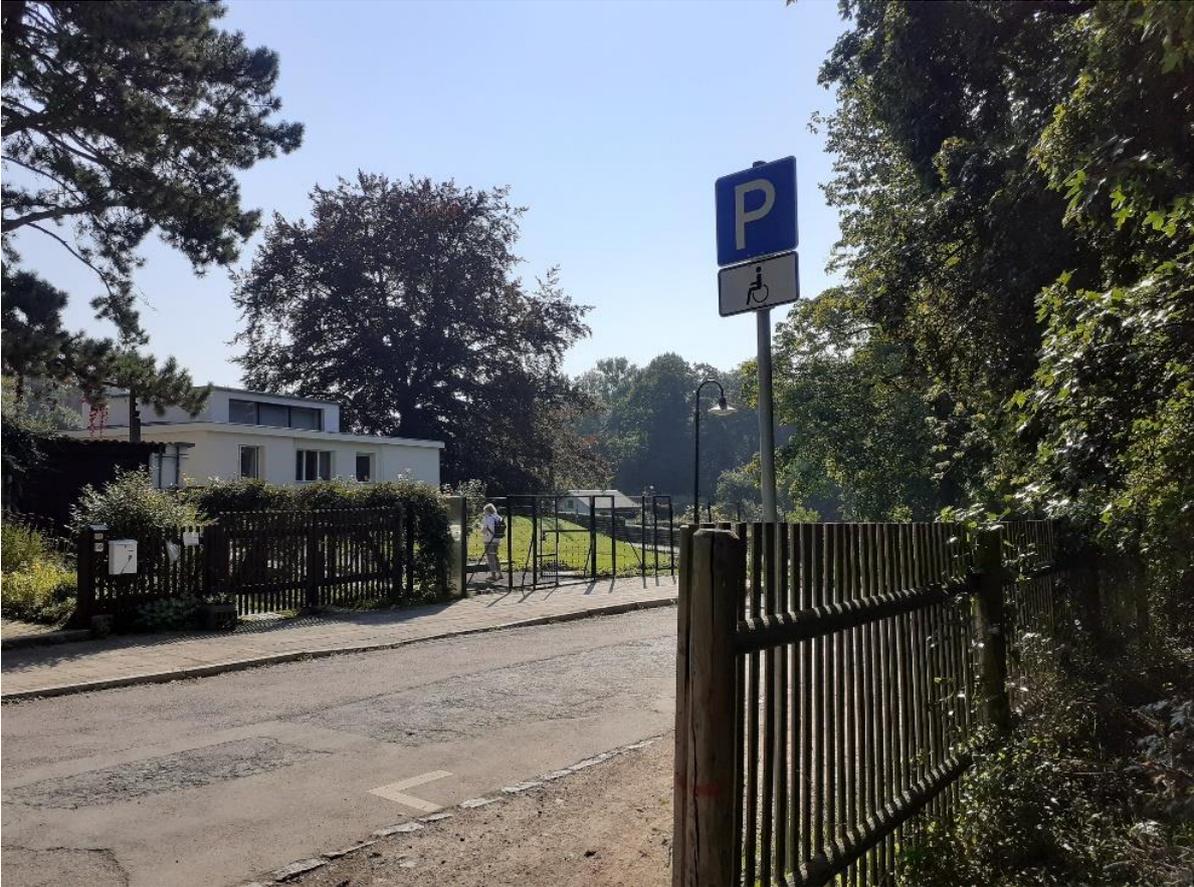
However, the famous house is visited by many tourists who park along the narrow street. That is why the line of parking cars sometimes reaches several hundred meters. Therefore, there are two parking spaces in front of the property only for people with special needs.

FIG. 8 Haus am Horn – two parking spaces in front of the property for people with special needs

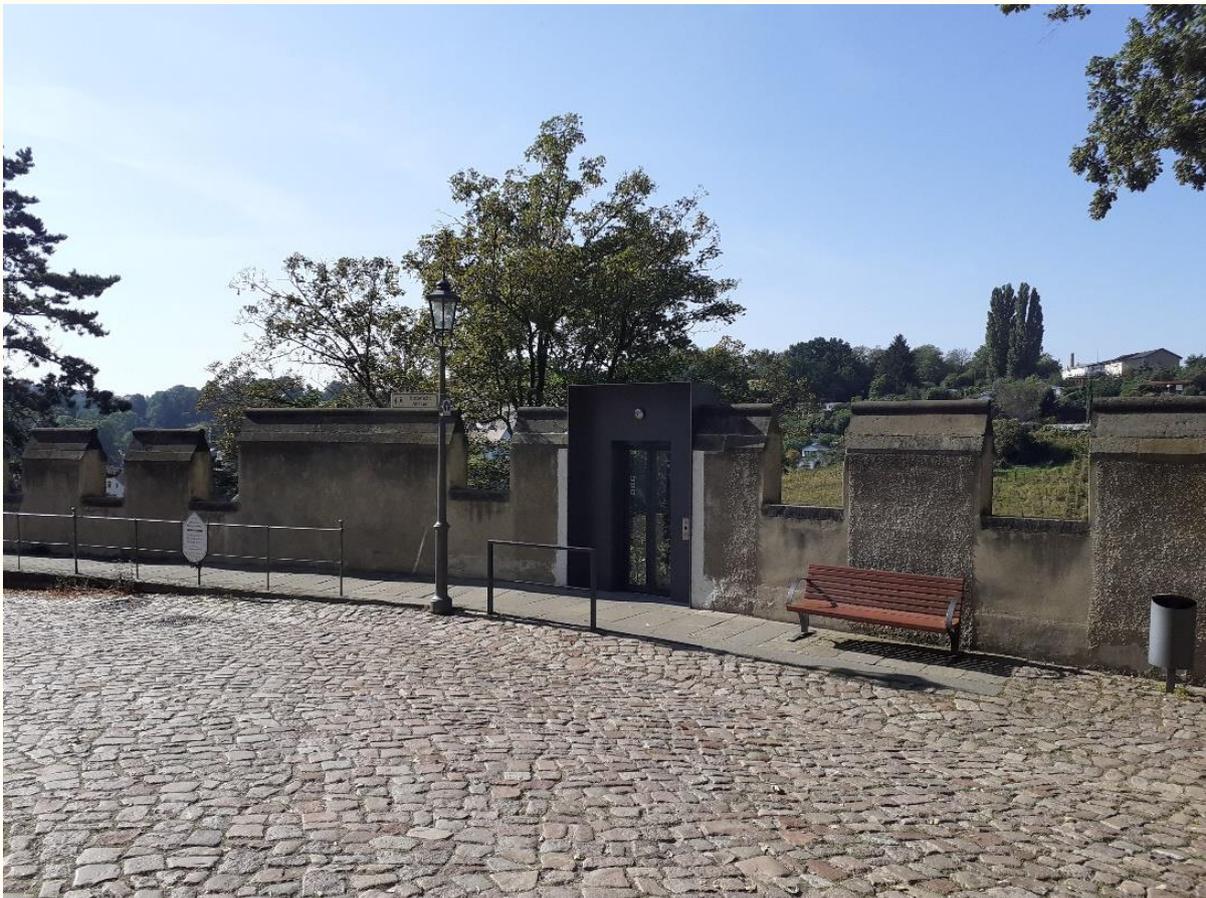
The cathedral square and the surrounding buildings are the central place of the castle hill in Meissen. Getting in and out of the narrow, cobbled streets of the old town is difficult. People with limited mobility can reach it only by using various means of transport. That is why a special bus line runs to the cathedral square, which is serviced by small vehicles and a funicular.

FIG. 9 The entrance to the funicular built into the wall surrounding the cathedral square in Meissen

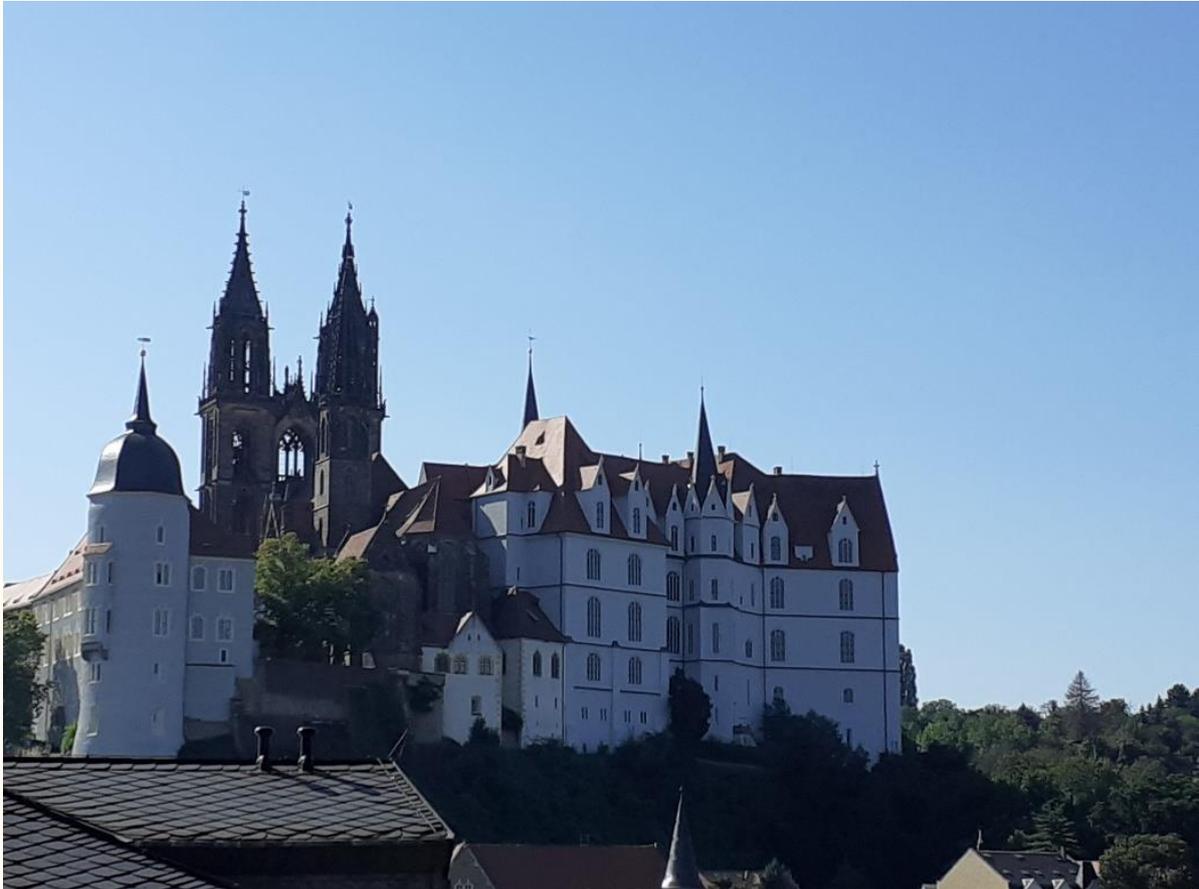
you cannot see any devices of the funicular, and its doors have been integrated into the historic wall.

FIG. 10 The panorama of the old town from the Elbe side is not disturbed by the devices of the funicular leading to the castle hill

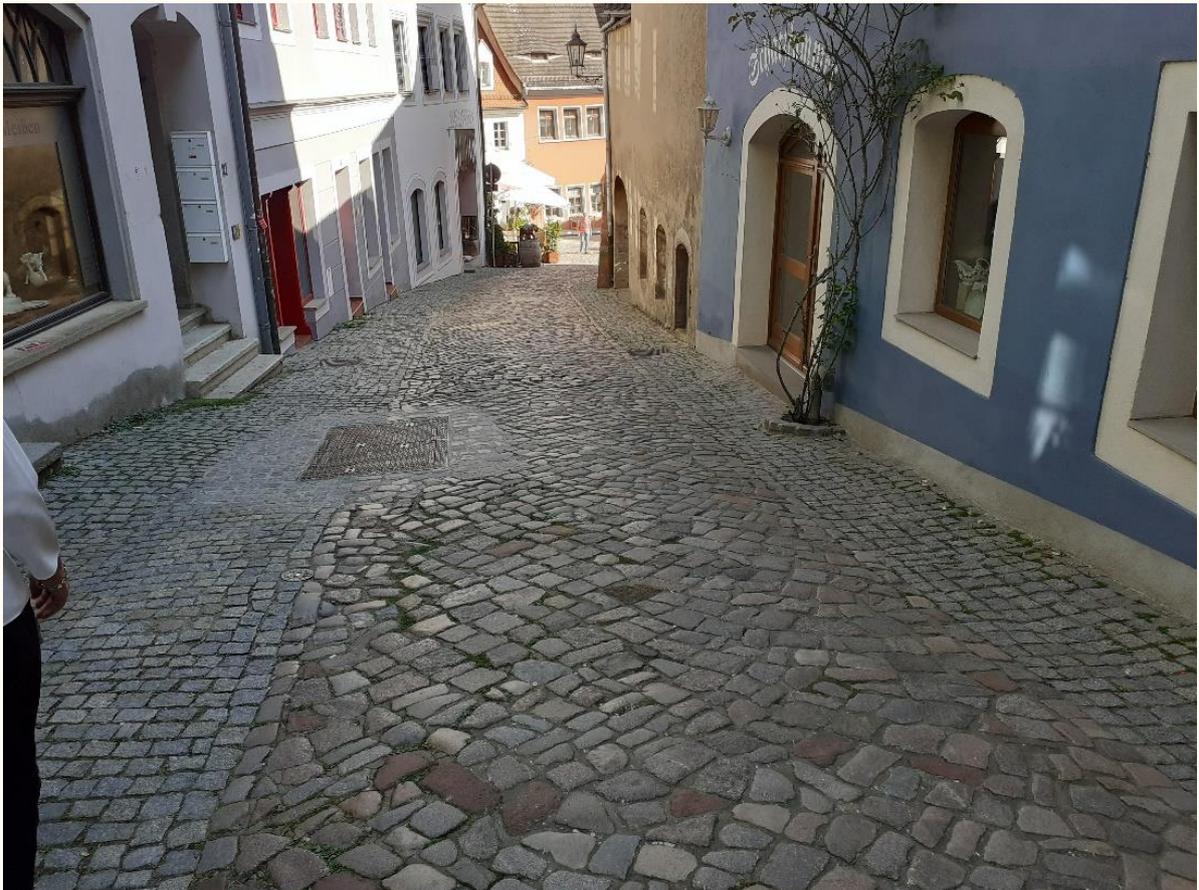
When visiting the old town, taking advantage of all its attractions, you have to move along the old town streets. Very often their surfaces are historical or reconstructed pavements. Moving - especially on longer stretches - on such terrain is very difficult for people with limited mobility.

FIG. 11 Old town streets are very often covered with historical or reconstructed pavements

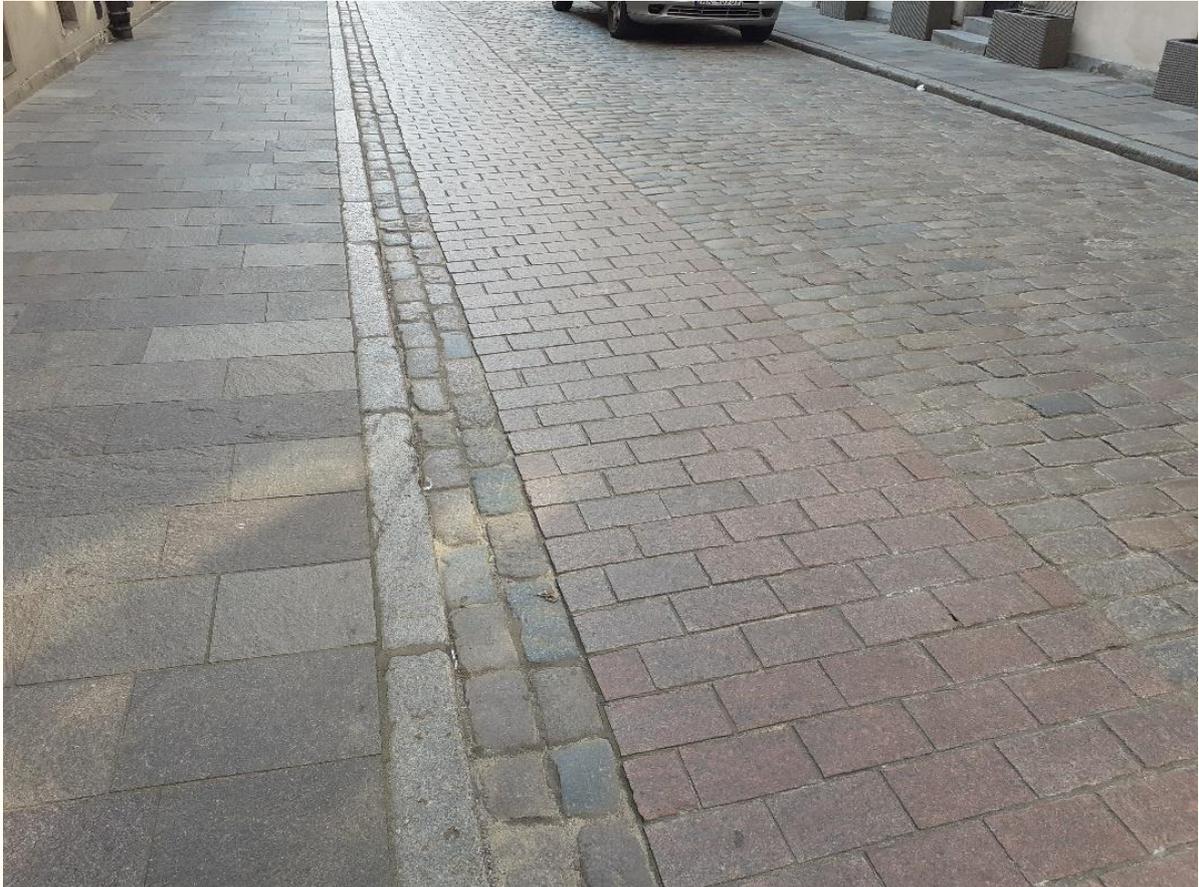
are used not only by people with limited movement, they are also easier to move around with strollers, bicycles, etc.

FIG. 12 The lanes that make it easier to navigate the cobbled streets in the Old Town in Warsaw

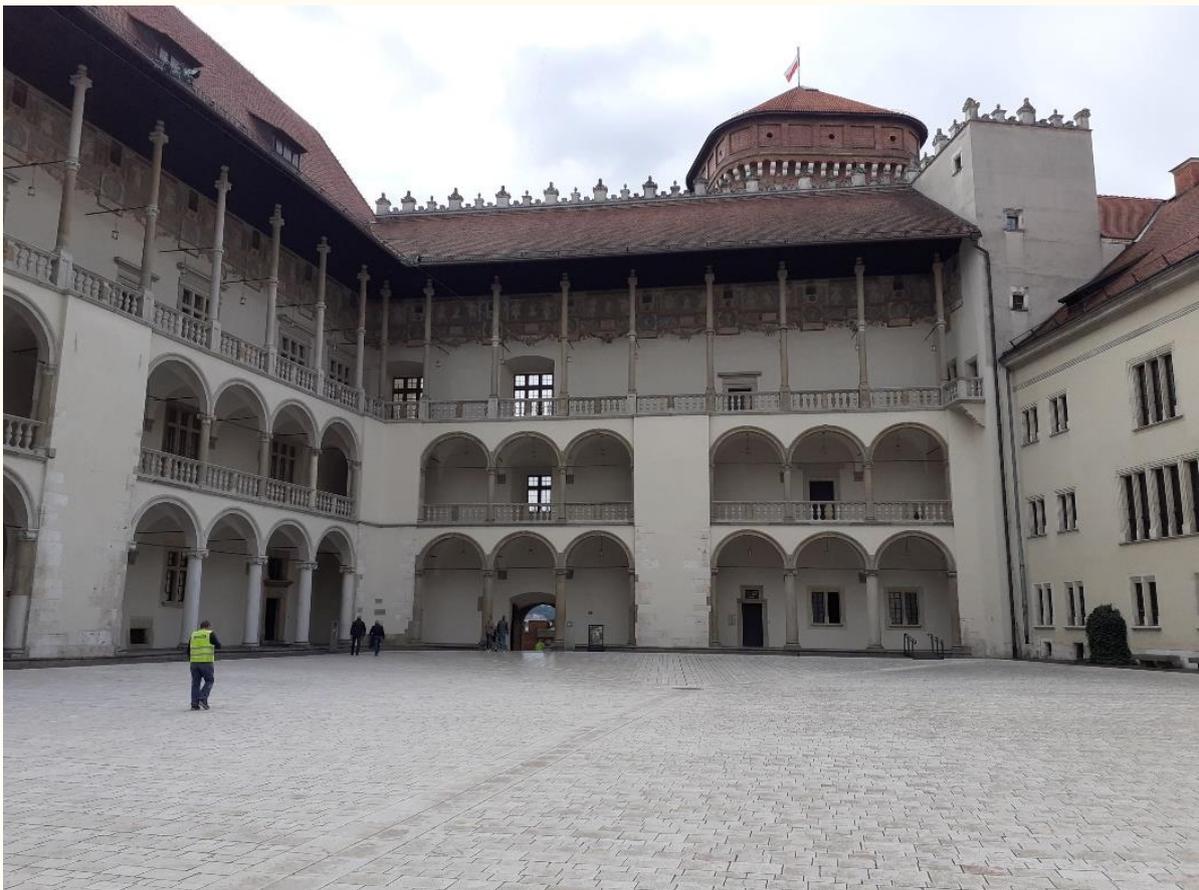
The courtyard of the Wawel Royal Castle was lined with stone slabs. Tourists visiting Wawel repeatedly cross the courtyard, as separate entrances lead to different wings of the complex. Therefore, from the point of view of the accessibility, the surface of the courtyard is very important.

FIG. 13 The surface of the Wawel courtyard was entirely made of smooth, stone slabs

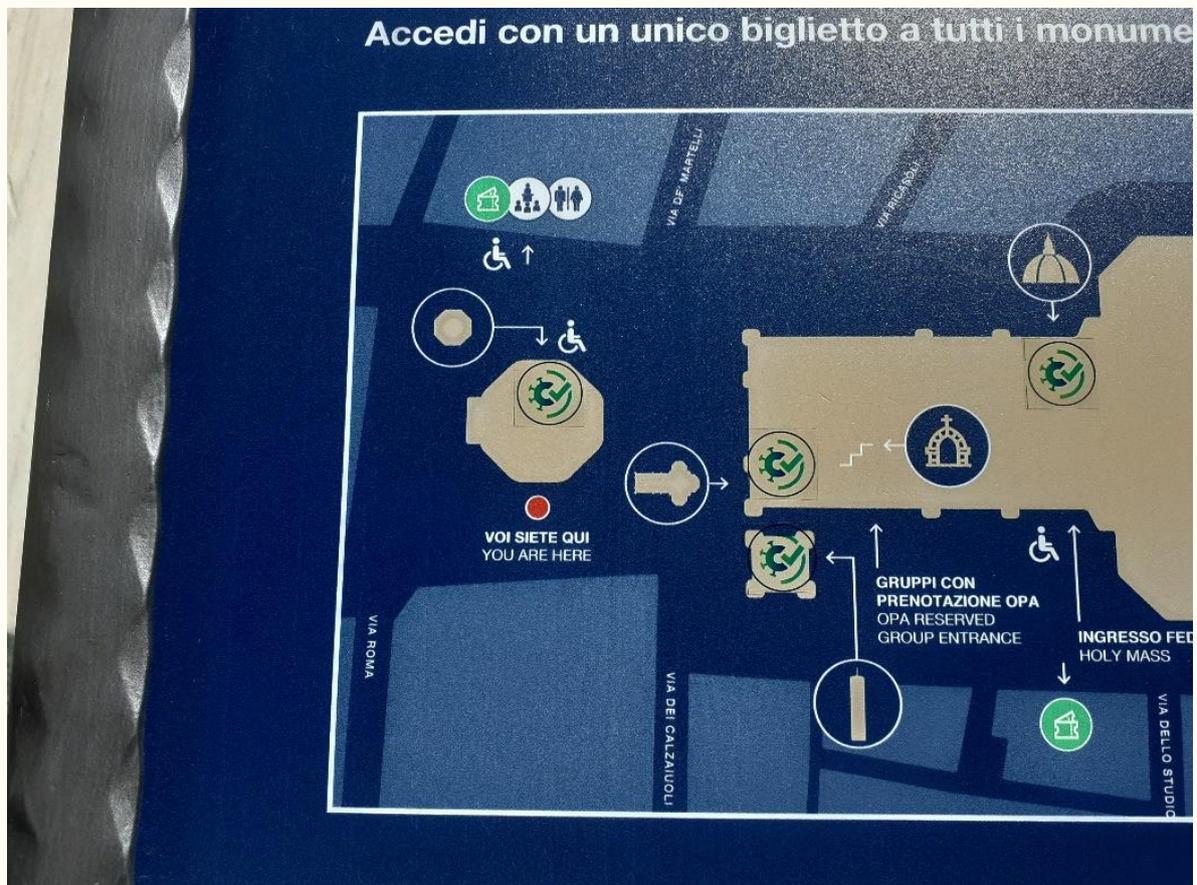
FIG. 14 Information for visitors – alternative entrance for tourists with disabilities

For people with reduced mobility, there is an alternative entrance in one of the side facades. The level difference by this entrance is small, therefore no additional accessibility devices are needed. In addition, entering the cathedral through these doors is easier, as there are still many tourists waiting at the front entrance. It is an example of an alternative entrance, good both for conservation and functional reasons.

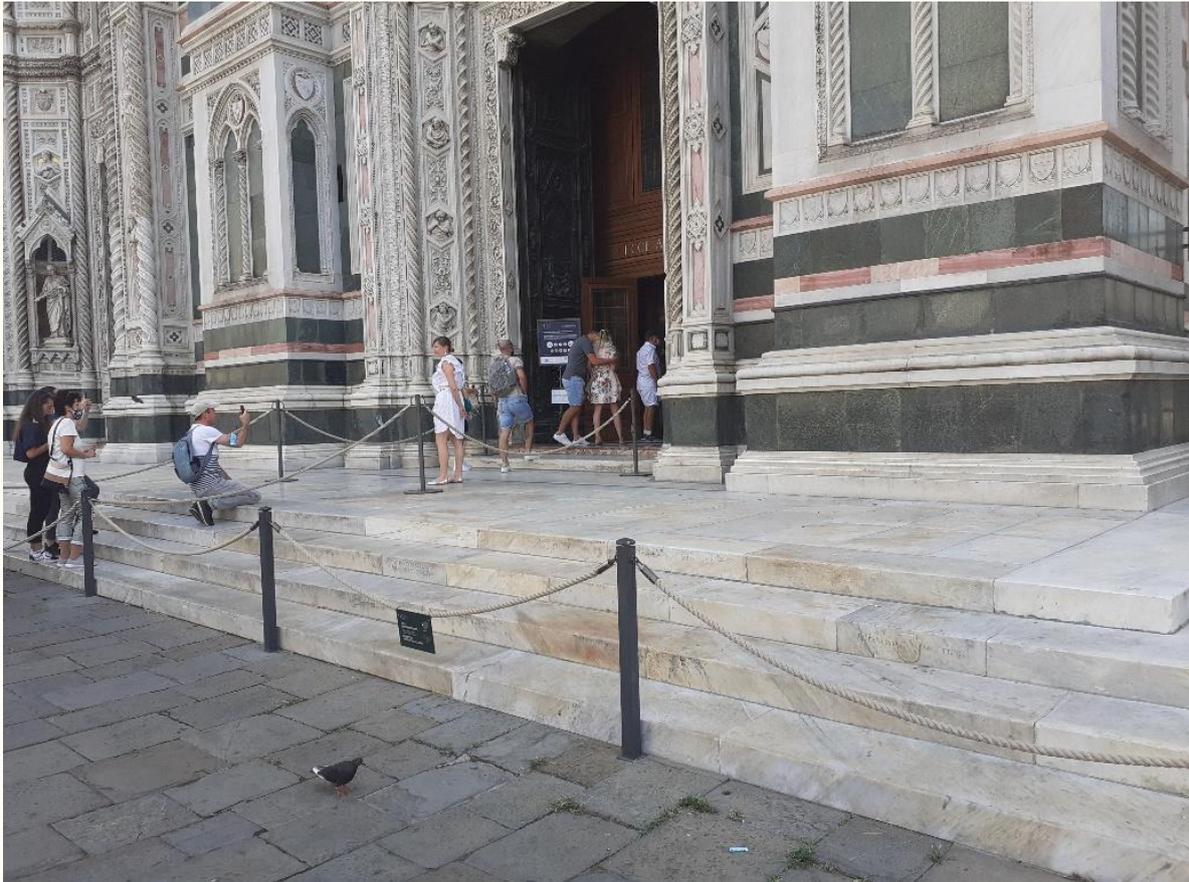
FIG. 15 Main entrance to the Duomo in Florence

In the surrounding streets and in Piazza del Duomo, most of the architectural barriers have been removed. However, in the cathedral, due to its unique value, any interference is kept to a minimum. Therefore, no accessibility measures were installed at the main entrance.

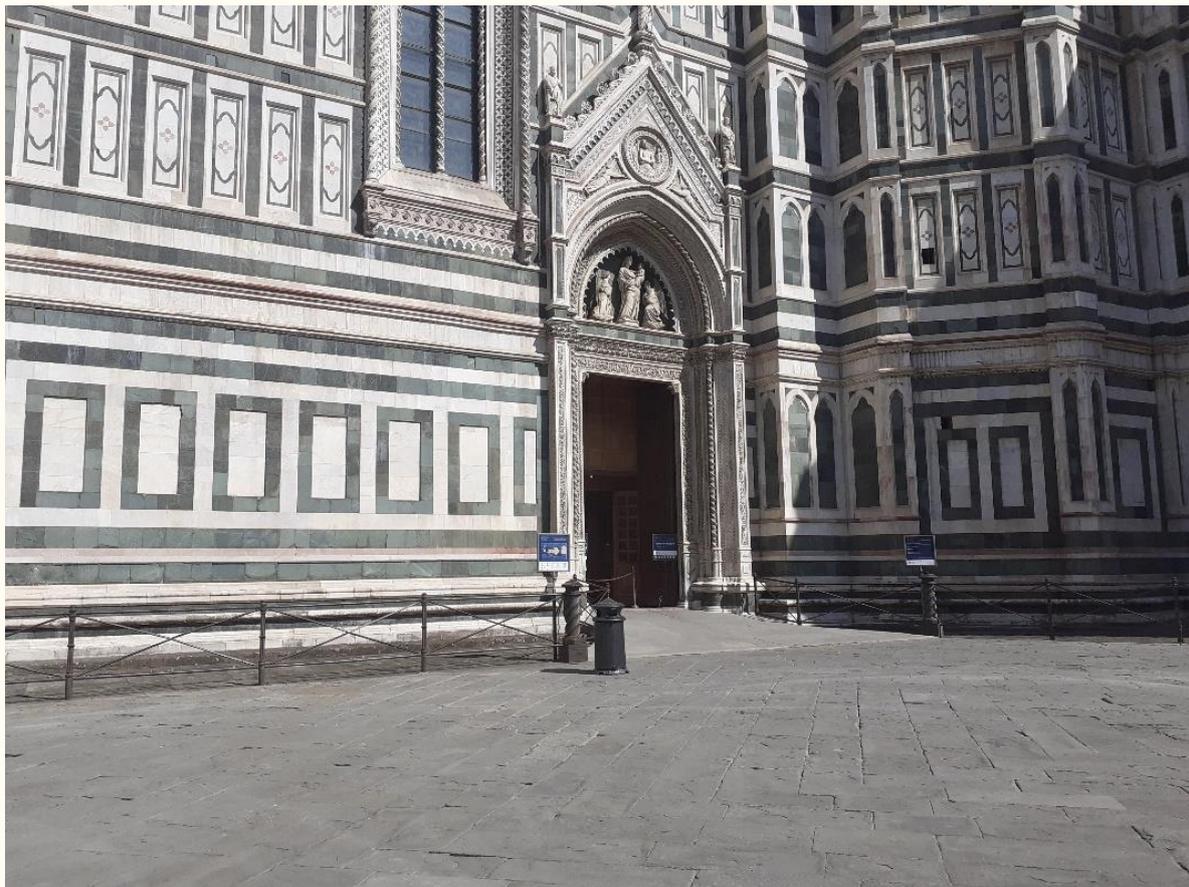
FIG. 16 The alternative entrance to the Duomo cathedral in Florence does not have any architectural barriers

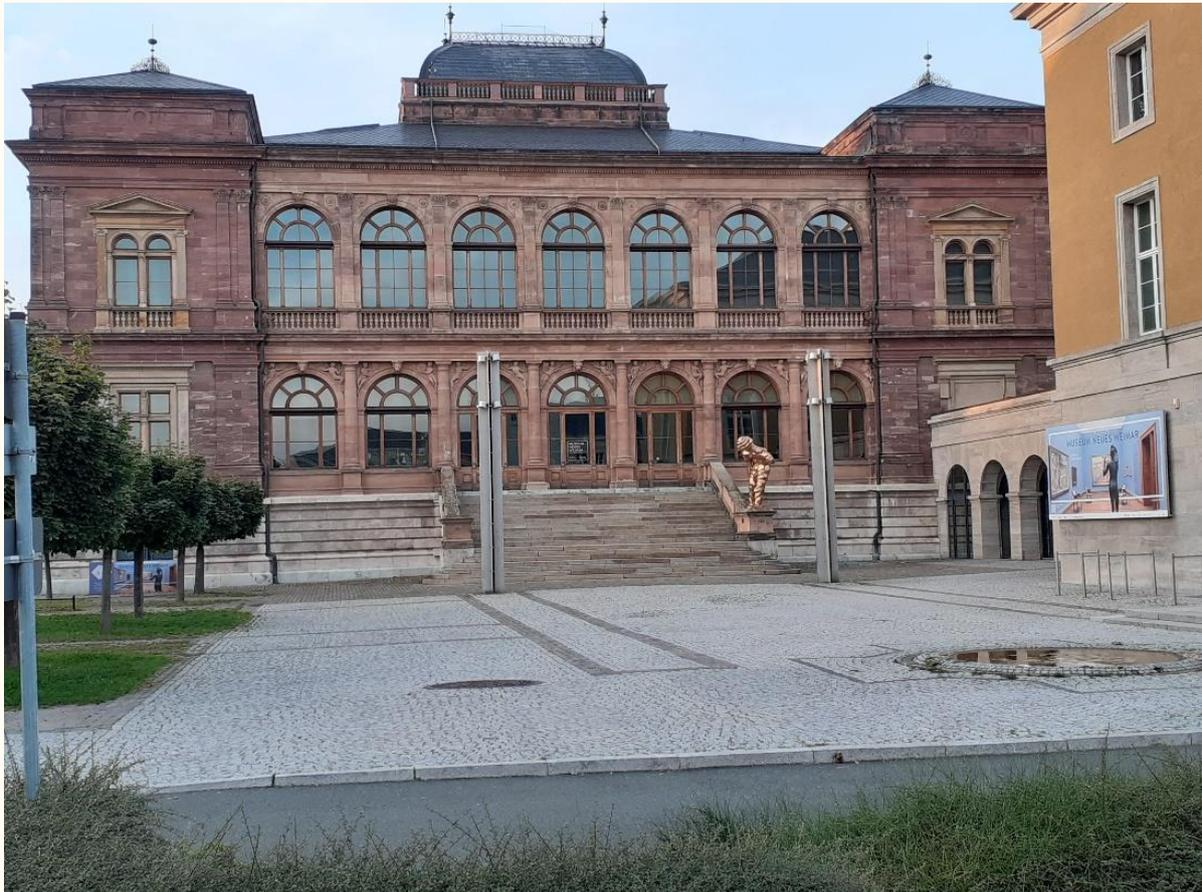
FIG. 17 Main facade of the Neues Museum Weimar building - high stairs

Wide stone steps lead to the main entrance to the Neues Museum building in Weimar. The staircase is long, as the representative storey of the museum is elevated high above the ground level.

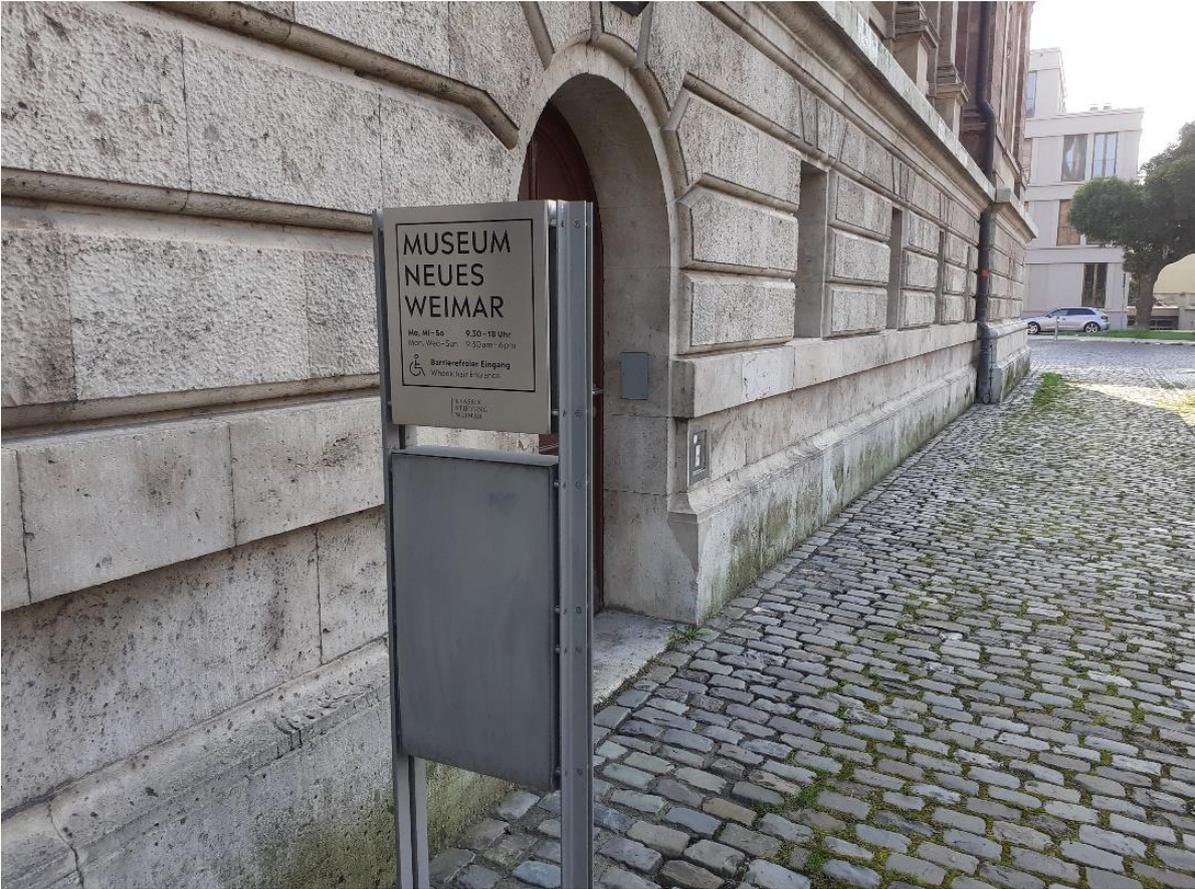
Therefore, for people with limited mobility, an alternative entrance was organized in the rear facade of the building, where one of the technical entrances was used. The entrance is barrier-free, it is located directly on the ground level, there is no threshold that would make it difficult to enter the wheelchair. An important advantage of this solution is the possibility of direct drive-up by a car - a person in a wheelchair will be directly in front of the museum's door.

FIG. 18 Entrance for people in wheelchairs - at ground level, without a threshold, the possibility of direct access by car / Neues Museum Weimar /

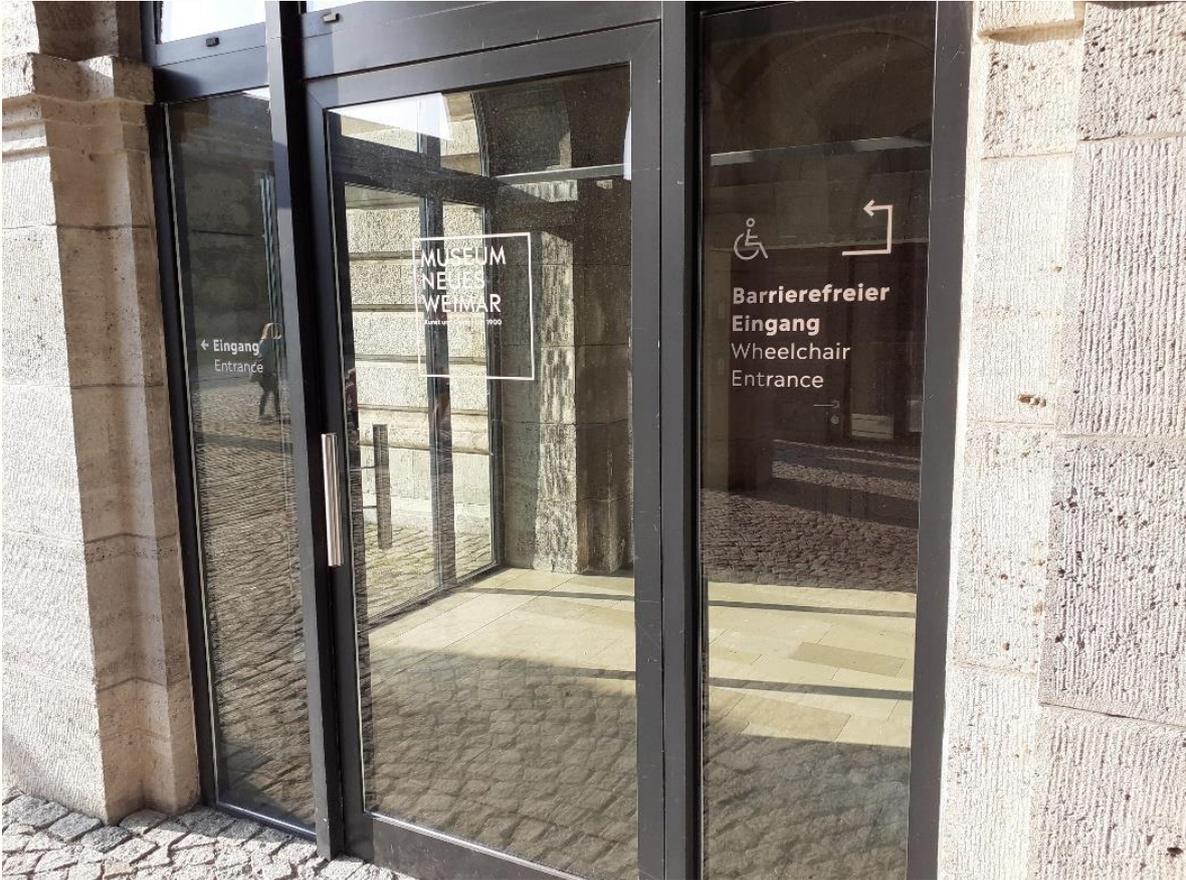
FIG. 19 Information explaining the location of the entrance for people in wheelchairs / Neues Museum Weimar /

Information explaining the location of the entrance for people with reduced mobility is provided by the main entrance for visitors to the museum.
