Adaptation of historic buildings for disabled people

Project UNINET: University Network for Cultural Heritage – Integrated Protection, Management and Use

Lublin University of Technology

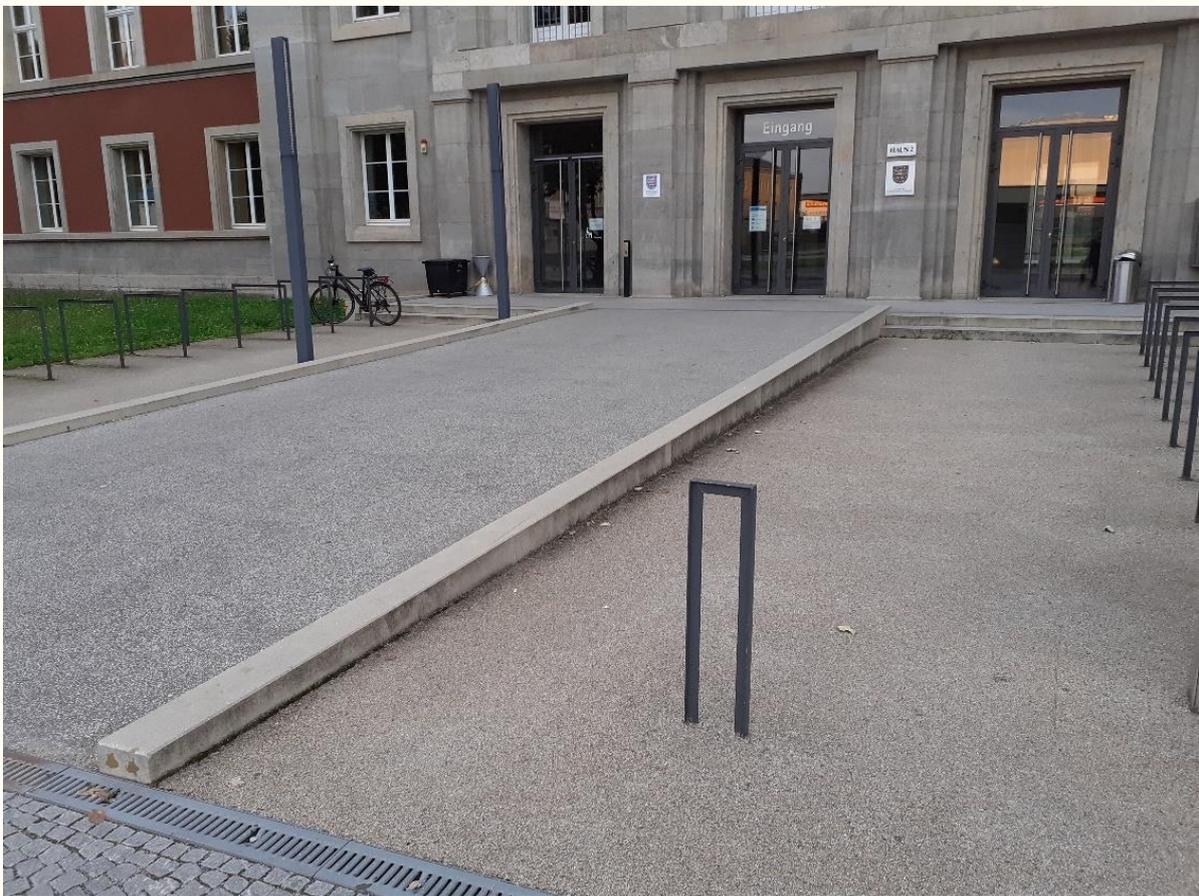
An example of a ramp added to a historic staircase in one of the office buildings in Weimar. The architecturally simple building was built in the fascist times. The entrance to the first floor is several dozen centimeters above the ground level and requires climbing a few steps. To make it easier for people with reduced mobility, a long ramp has been built, which is easy to overcome on a wheelchair. The ramp has a slight slope as it starts far in front of the stairs. The ramp is perfectly integrated into the alley leading to the entrance, it is harmonized in color and material.

FIG. 20 Ramp leading to an office (historic building) in Weimar

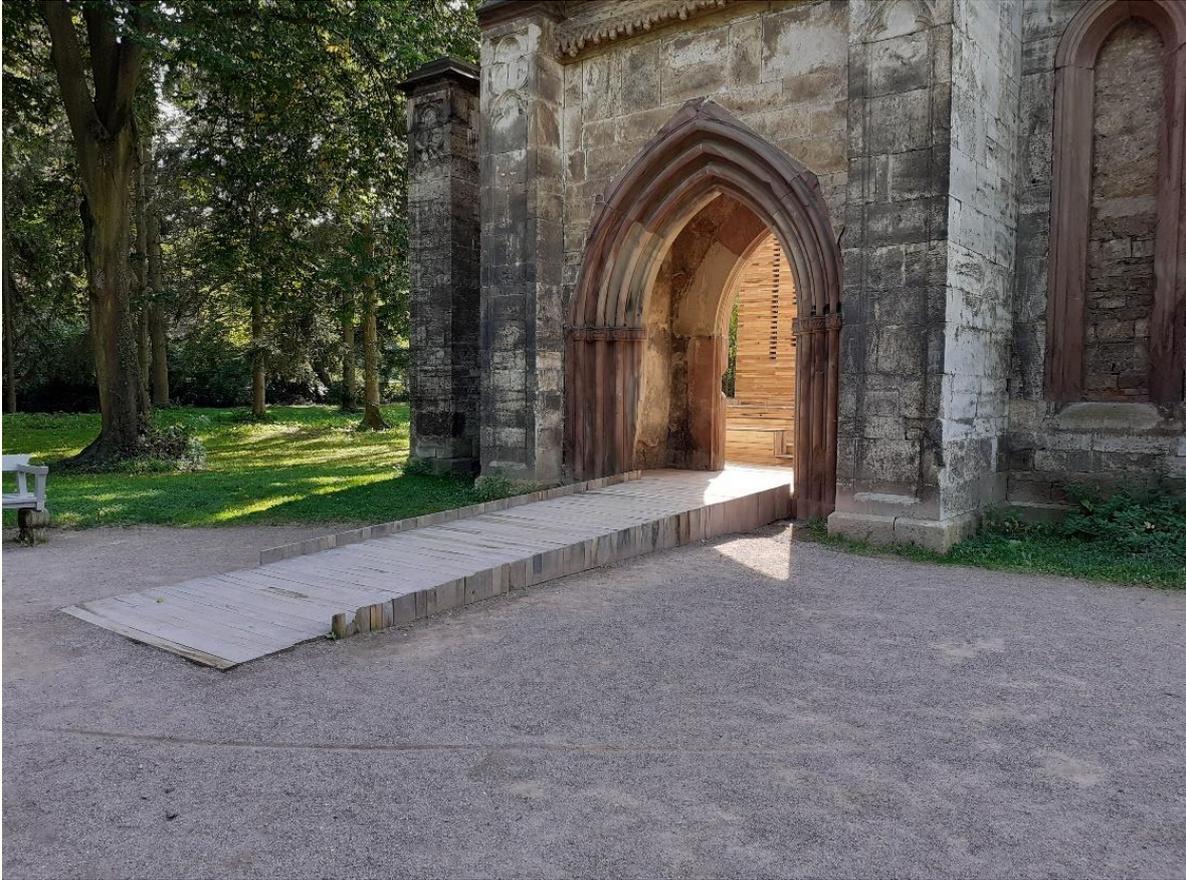
Steps to enter the ruins have not been made, although it is open to the public. Therefore, a wooden ramp was added at the entrance. A simple form and natural material are appropriate in this setting and in a facility of this nature. If the concept of using this monument changes, it will be easy to remove the wooden ramp.

FIG. 21 Ramp leading to a historic ruin in the Weimar nature park

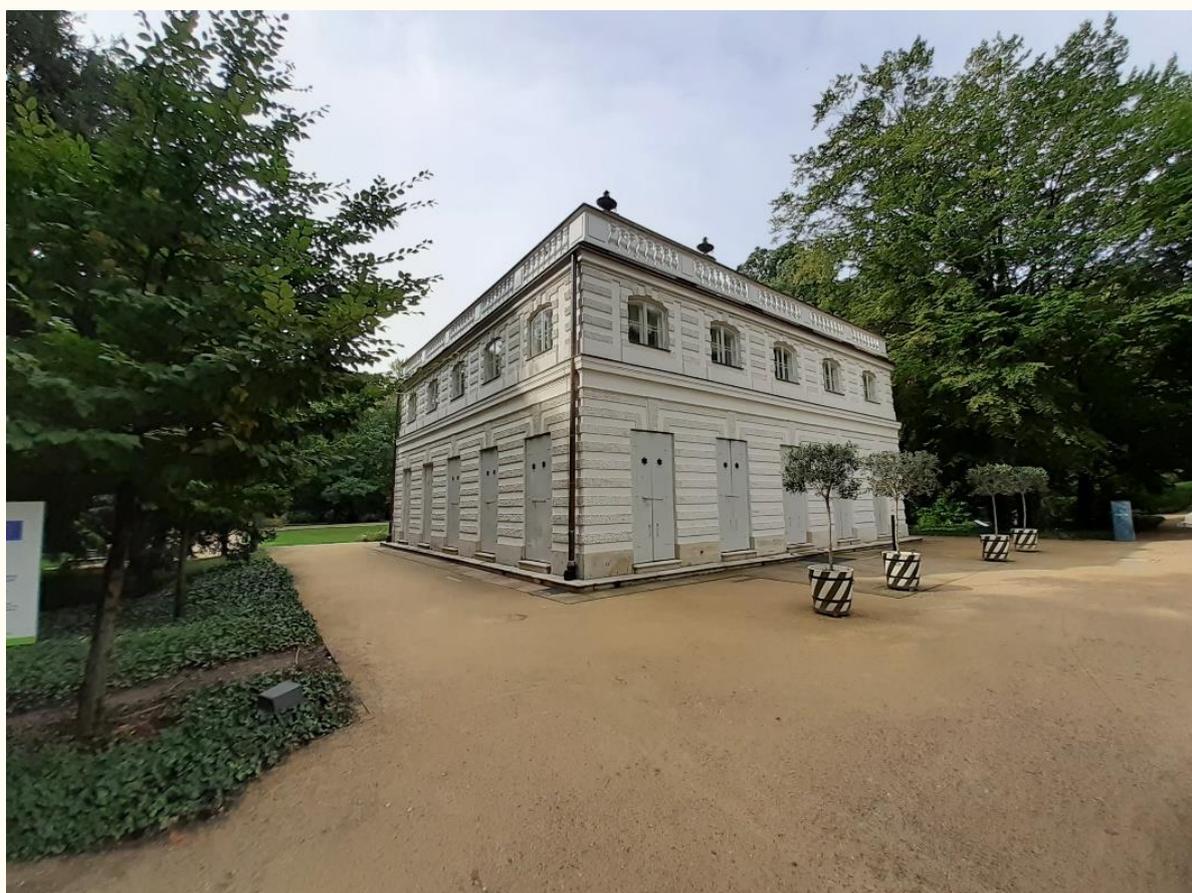
FIG. 22 The pavilion is several dozen centimeters above the ground level

The White House is a small residential Warsaw. The pavilion was the first object erected in the complex, it has a valuable interior and is open to the public. The entrance door is not much higher than the level of the surrounding area, however, it is a barrier that prevents wheelchair access. Because of the historic value of the facility the accessibility was provided with a solution that does not interfere with the building at all.

In order to overcome the level difference, a lift was installed in the immediate vicinity of the entrance door. The device was hidden underground – when the lift is not being used it is not visible. When a user on a wheelchair appears, the facility staff starts the lift.

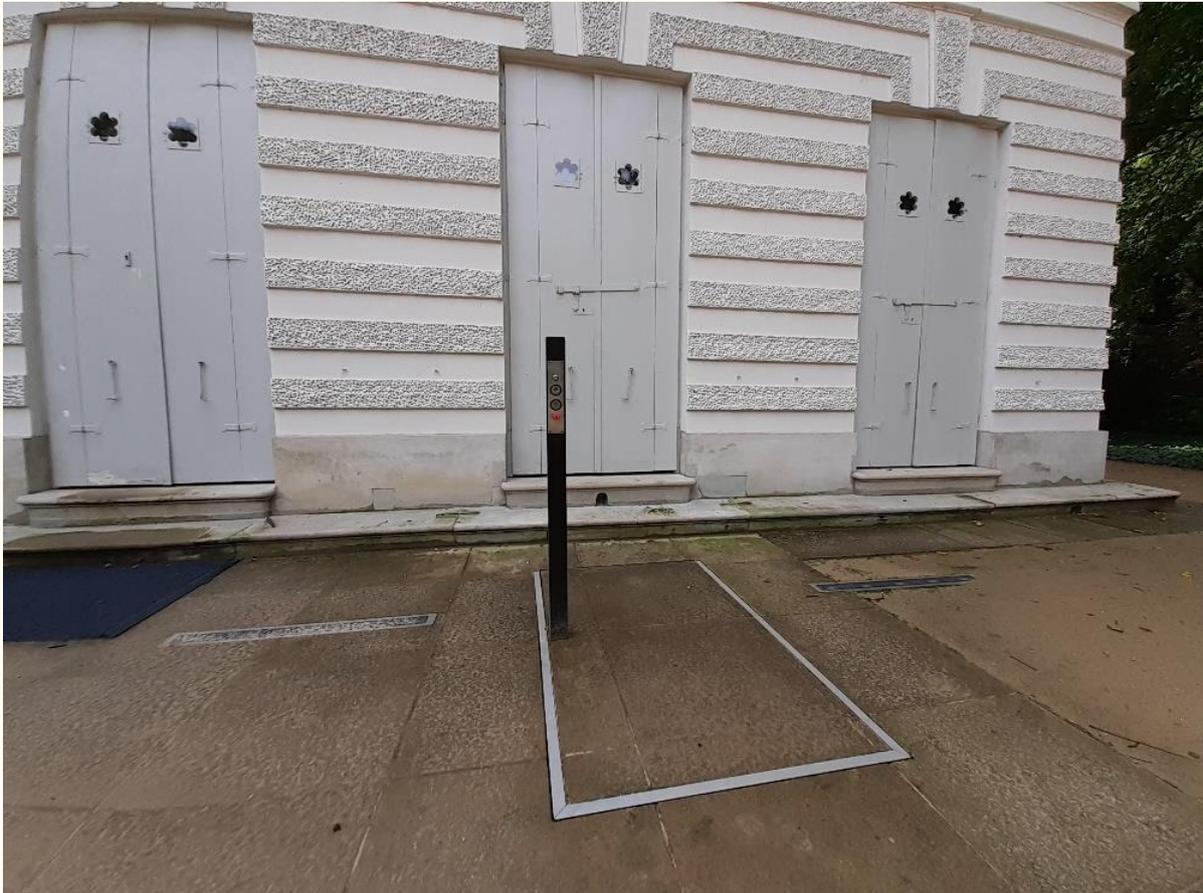
FIG. 23 The lowered lift is not visible

From a conservation point of view, such a solution can be considered a good one. In practice, however, the use of a lift requires quite a complex procedure and assistance. Moreover, the device may require maintenance and repairs in the long run.

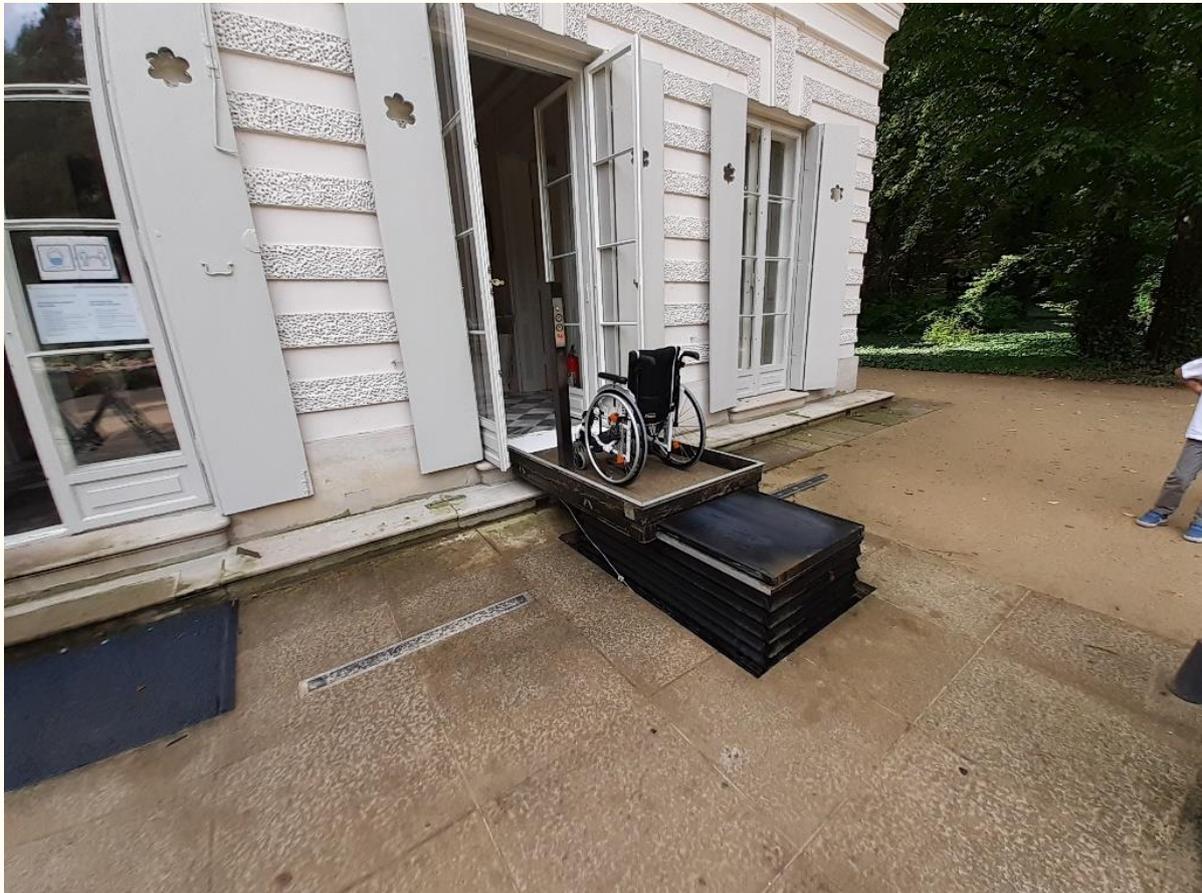
From the lift to the building one enters the landing, which is folded out by the facility staff.

FIG. 24 The wheelchair is raised by the lift

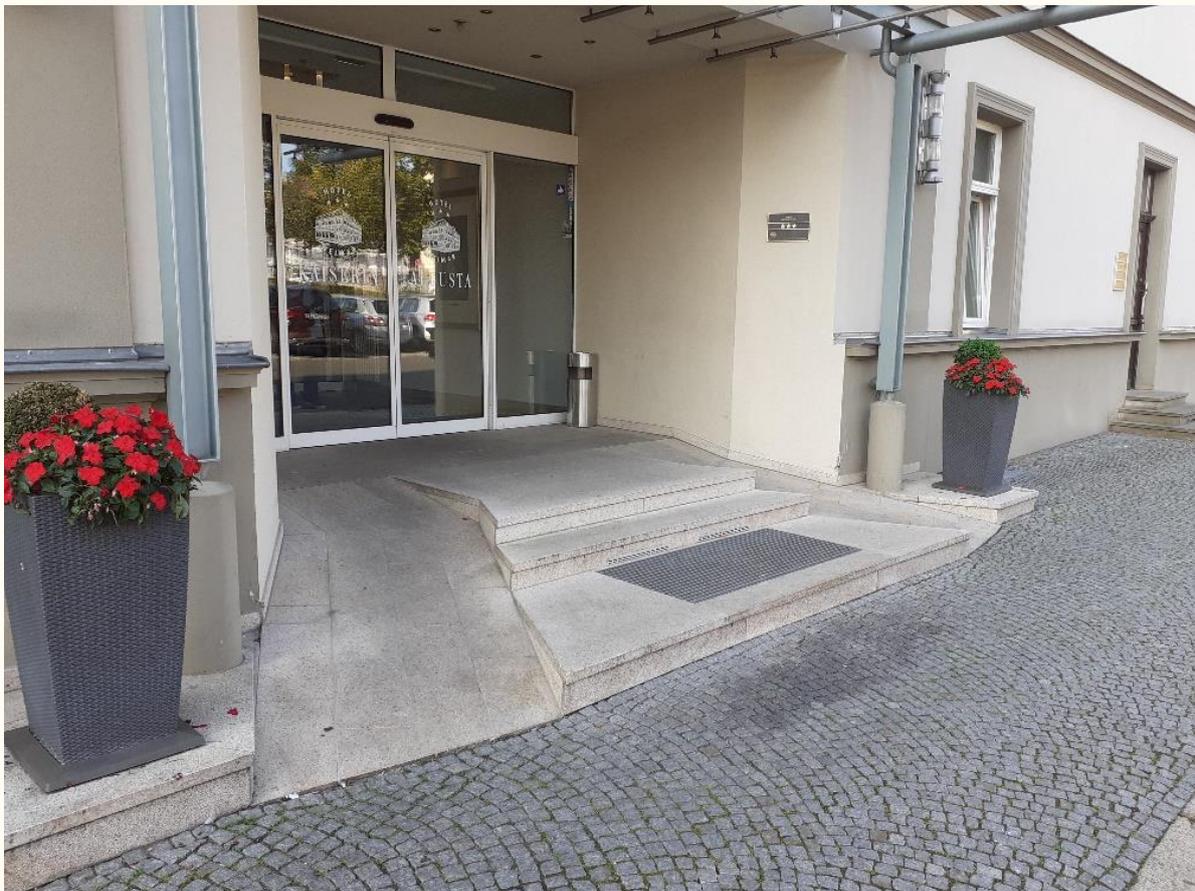
This solution can be used in buildings of low historical value, when the part of the building with the stairs was destroyed, or when it was decided to rebuild the historical facade.

FIG. 25 Rebuilt staircase at the Kaiserin Augusta hotel with two ramps

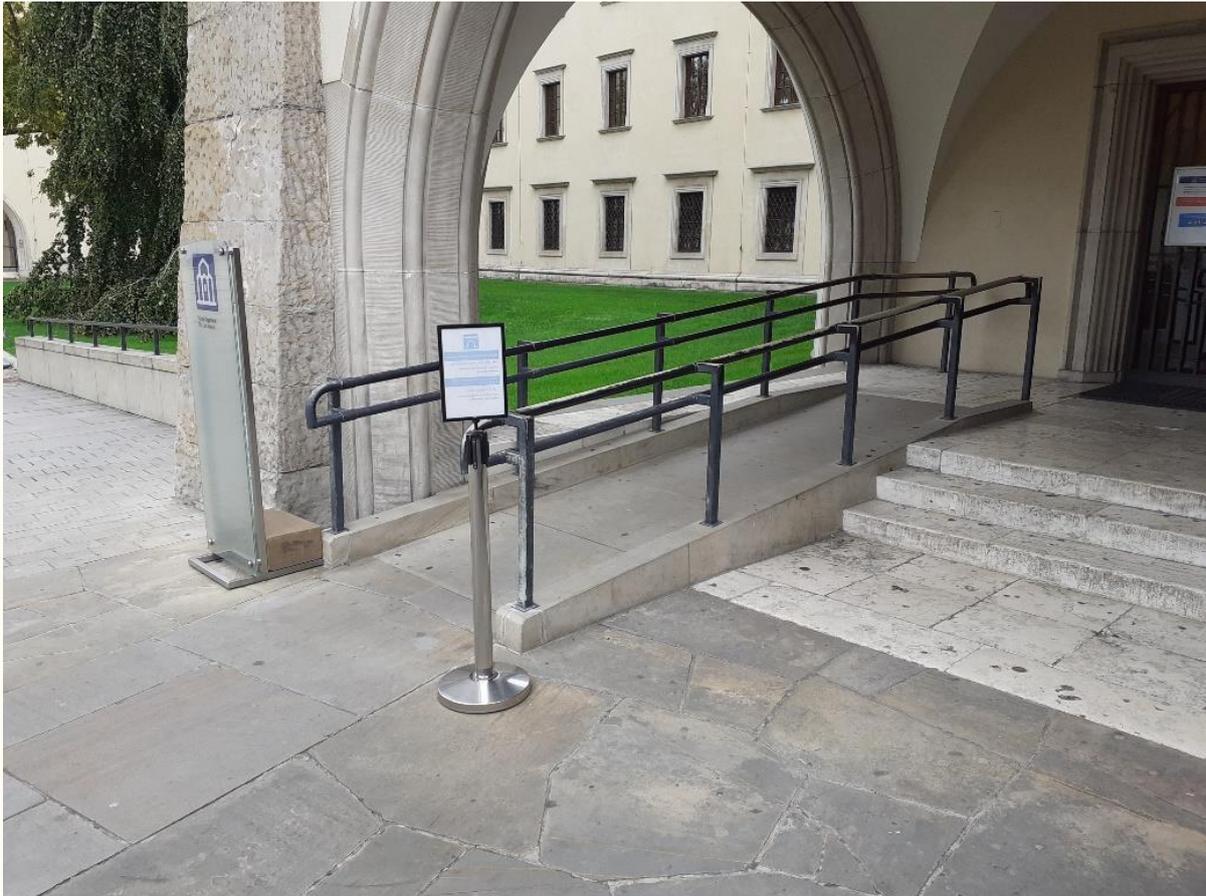
The Wawel complex has been adapted in many places to the needs of people with limited mobility. A low staircase leads to one of the newer buildings, which houses an exhibition of archaeological monuments. On their side there is a ramp, which is facilitated by a double-sided balustrade.

FIG. 26 The ramp built into the stairs leading to the exhibition of archaeological monuments of Wawel

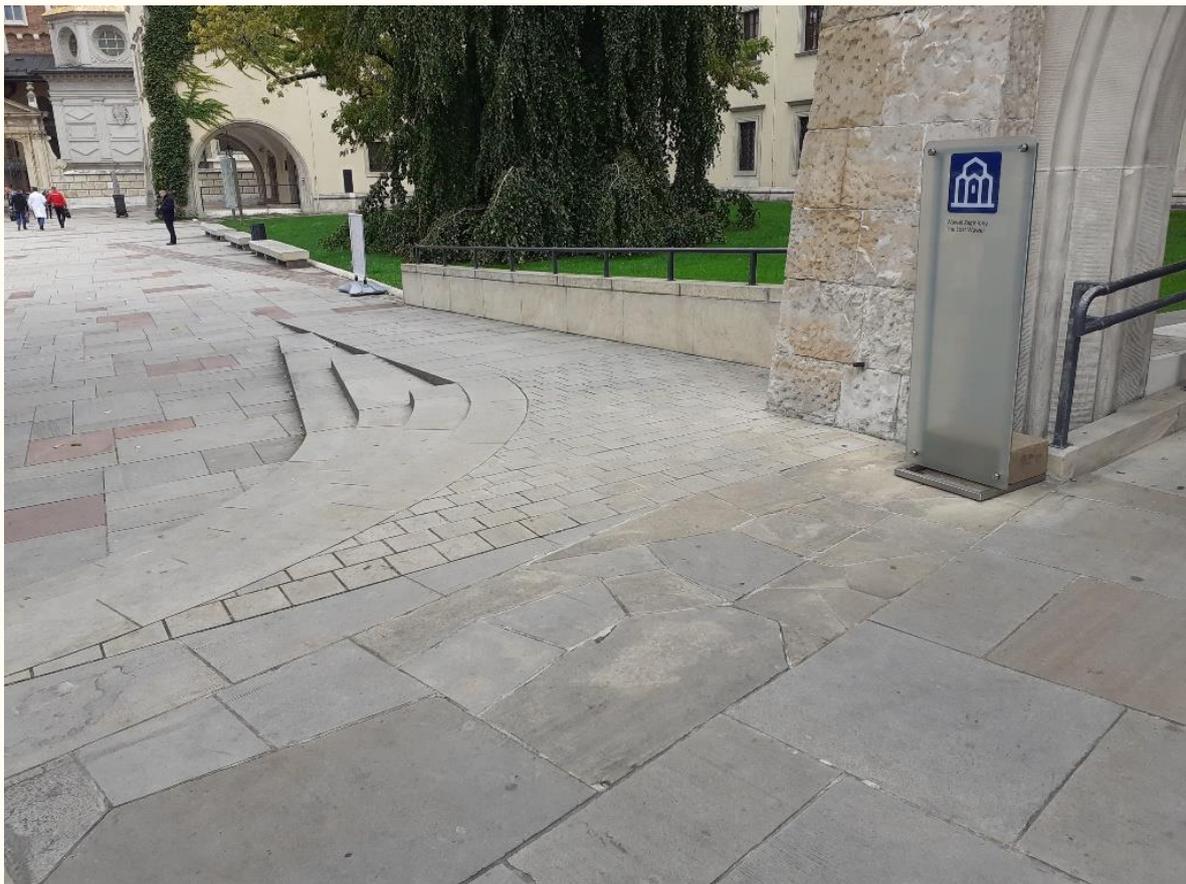
The building housing the archaeological exhibition is elevated above the level of the surrounding area. It is a small hill that can be climbed over several steps. To make it easier for people with limited mobility, a long ramp has been built next to the steps, which gently allows overcoming the difference in levels and getting into the building. The ramp has been successfully integrated into the space of the square.

FIG. 27 Ramp integrated into the square leading to the building with the archaeological exhibition of Wawel

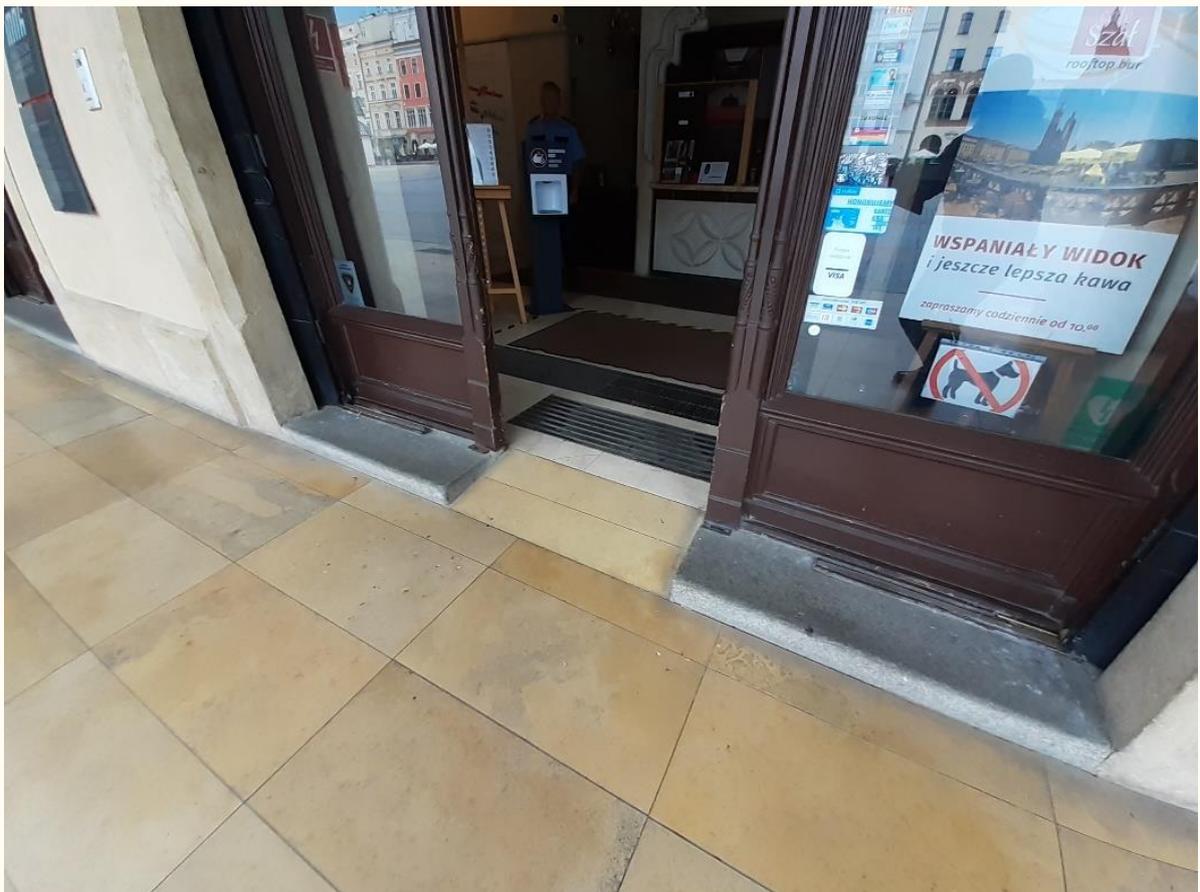
In this case, the entrance door was based on a stone slab of several centimeters, which protected wooden elements of the entrance and was a kind of a building band. The difference of levels between the threshold and the square was small, but it constituted a certain barrier. Therefore, the slab has been cut across the entire width of the door. The barrier has been removed.

FIG. 28 The slab forming the threshold in the entrance door to the Art Gallery Sukiennice has been lowered to the floor level

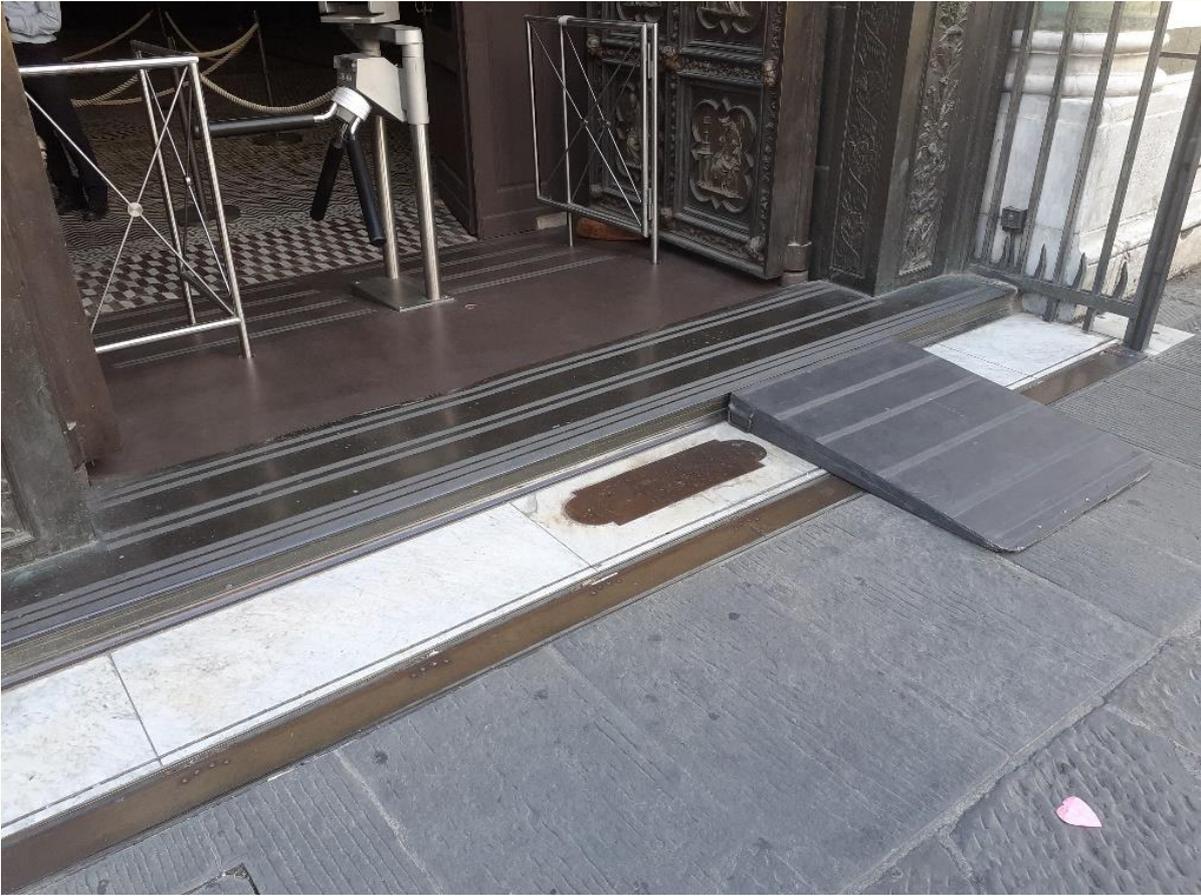
The Baptistery is part of the famous cathedral ensemble of Florence. The facility is constantly visited by tourists. Therefore, it must also be fully accessible to people with reduced mobility. In the case of such a valuable monument, any interference is unacceptable. Therefore, the threshold at the entrance to the building was not removed, but was leveled with a small rubber ramp. It is not a permanent barrier removal, but in this case it is the right solution.

FIG. 29 Leveling the threshold at the door to the Florence Baptistery ensures accessibility

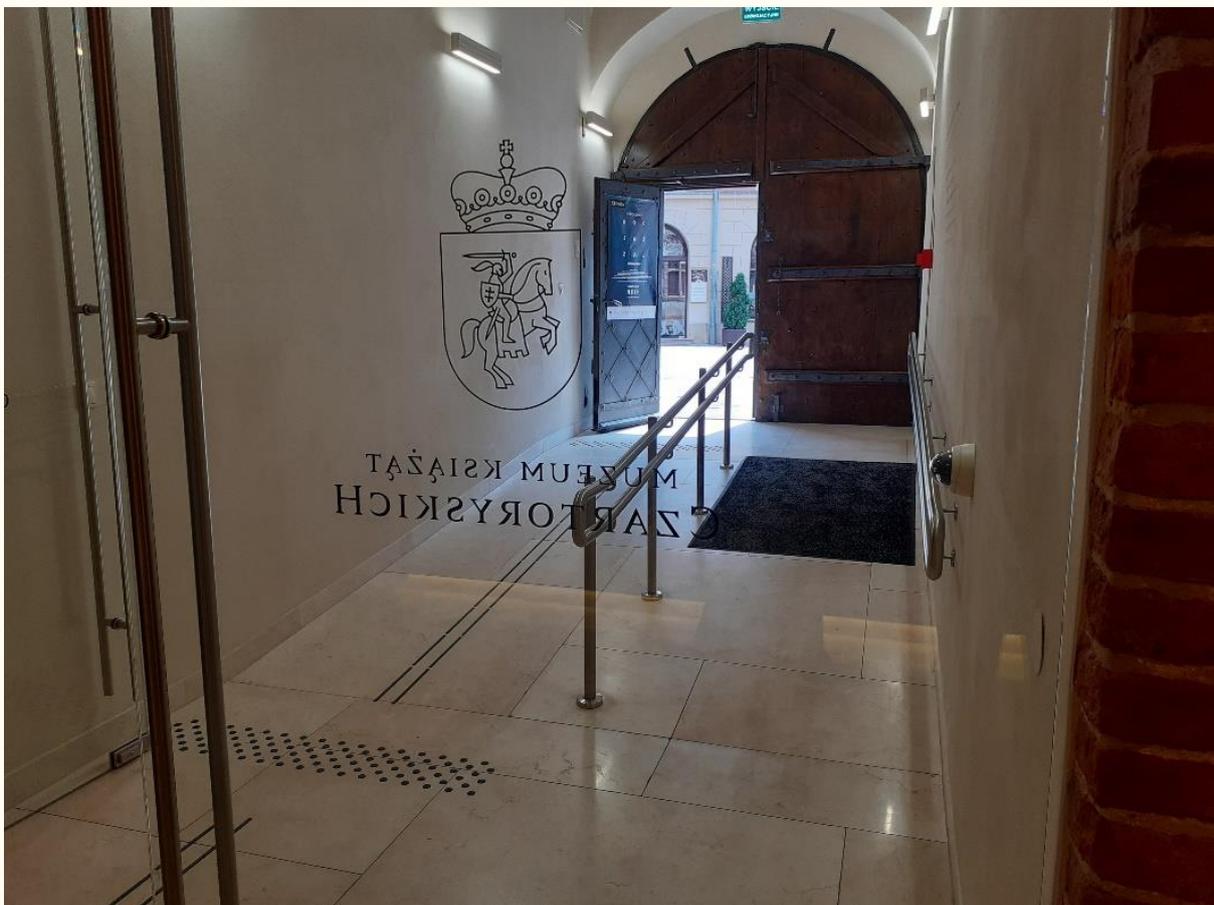
FIG. 30 Entrance to the Arsenal - the inclined floor connects the street with the first floor

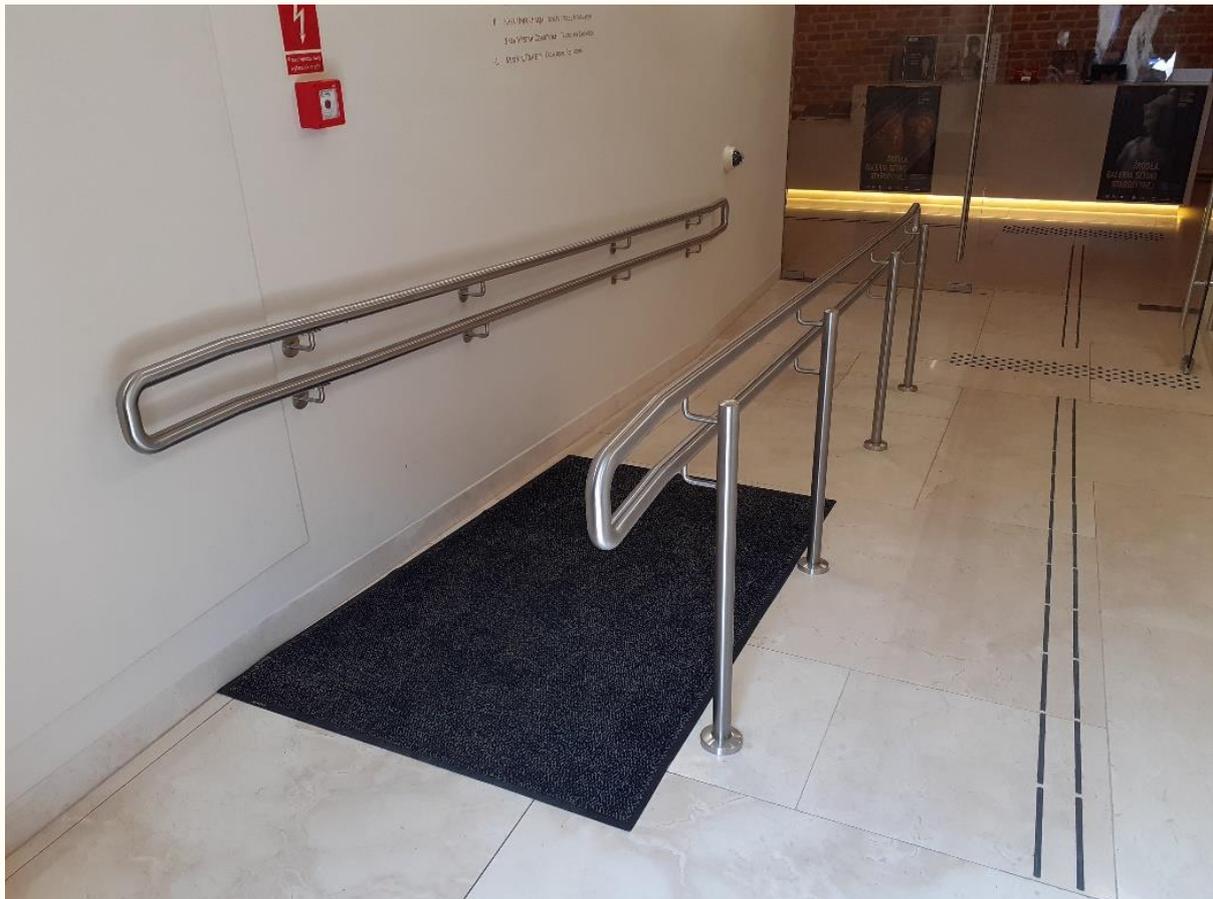
FIG. 31 The entrance room to the Arsenal has been divided into two lanes with a balustrade, one of which is intended for people in a wheelchair

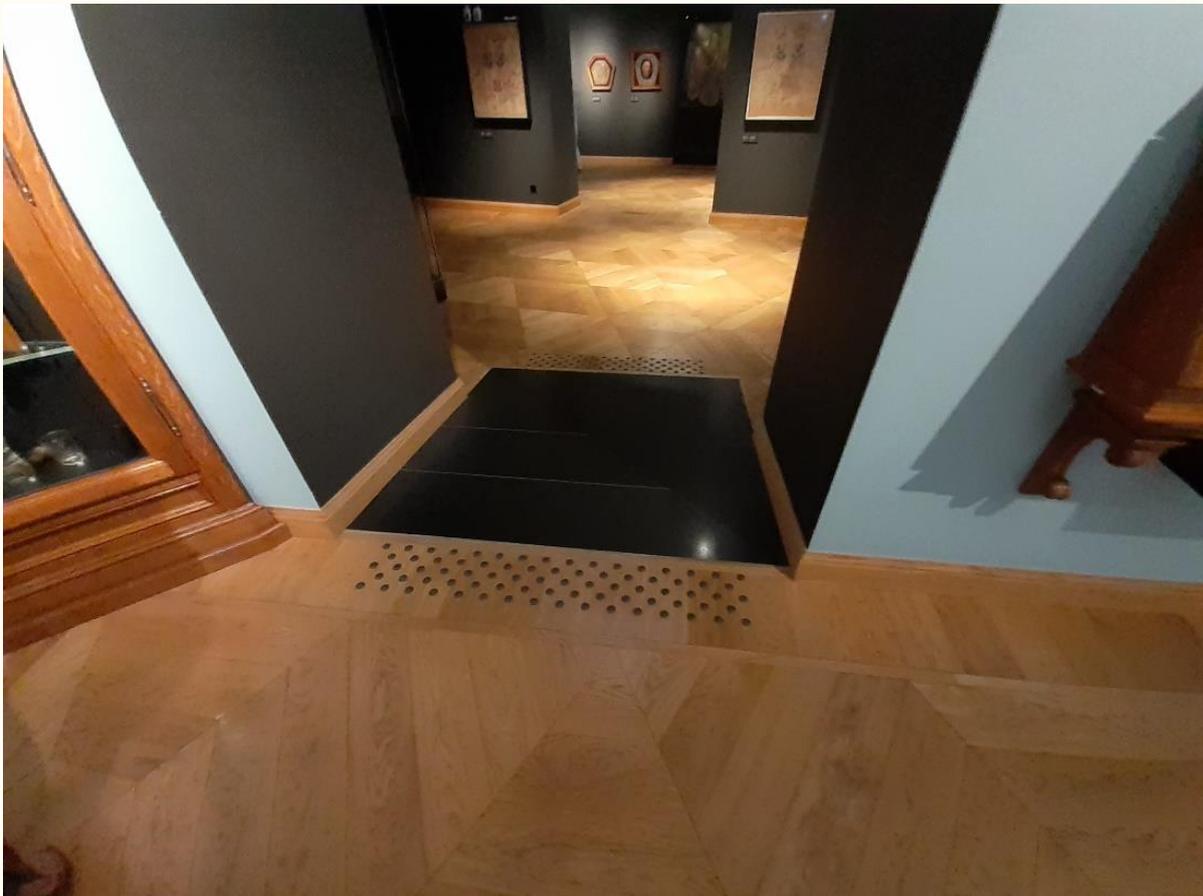
FIG. 32 Passageway between the rooms at the Czartoryski Museum - almost the entire section of the floor leveling the difference in levels is within the wall thickness

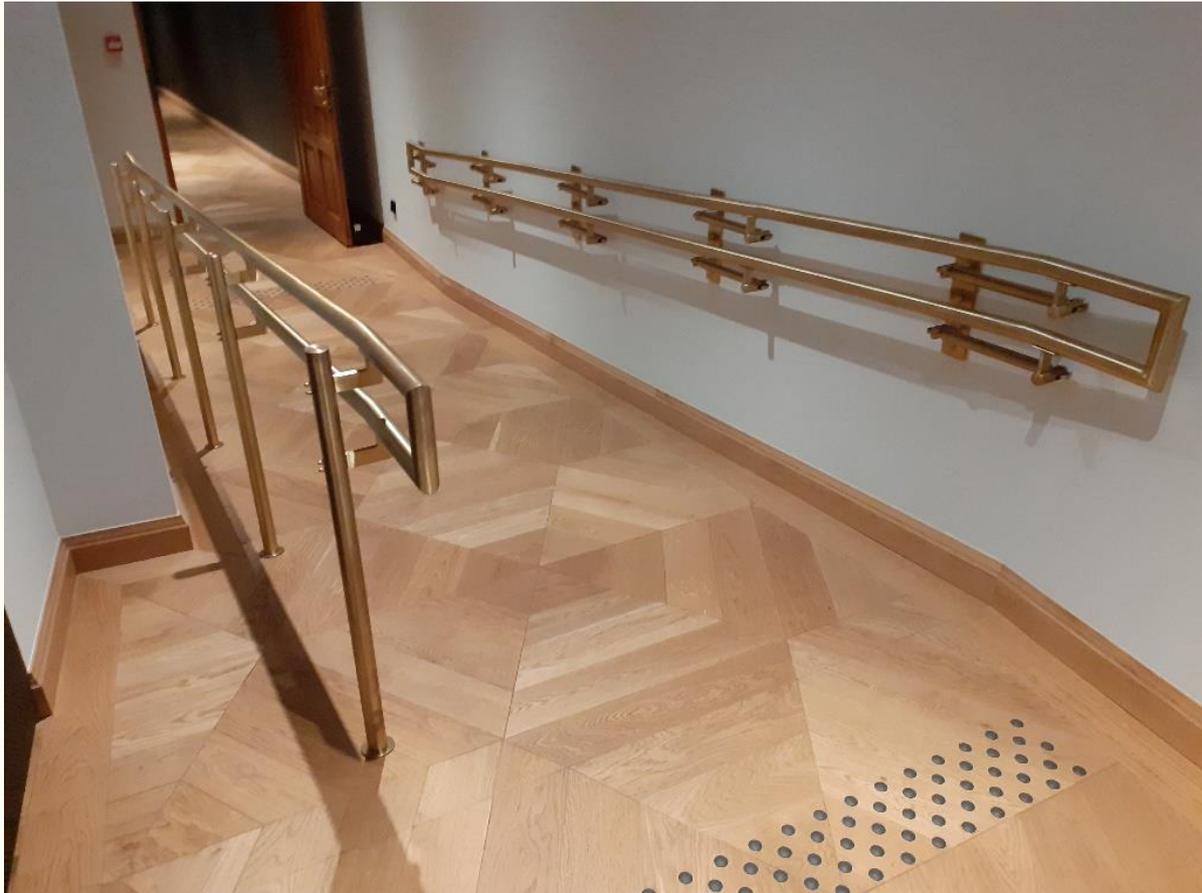
In the Czartoryski Museum, the differences in levels also had to be overcome in some of the corridors connecting parts of the historic building. The stairs were replaced with a floor. A corridor with a length of several meters allowed for a floor with a relatively small slope. There are handrails on the walls to help people with reduced mobility.

FIG. 33 A corridor in the Czartoryski Museum connecting rooms of different levels

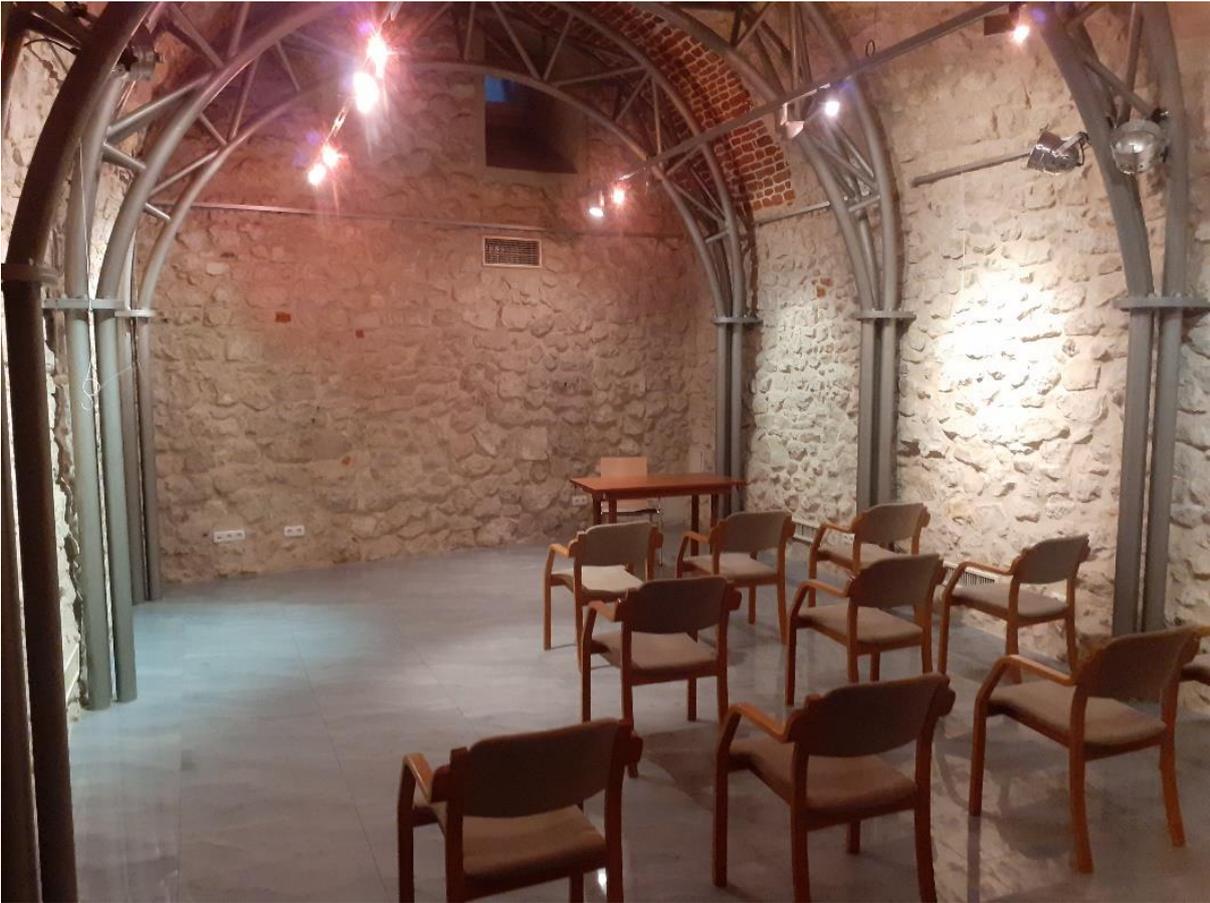
FIG. 34 A seminar room built in the basement of the International Cultural Center

A similar solution was used in the underground part of the International Cultural Center in Krakow. This institution is very active and in a certain period the rooms of the former tenement house in which the ICC operates became insufficient. It was decided to use the underground, among other things, by arranging an additional seminar room.

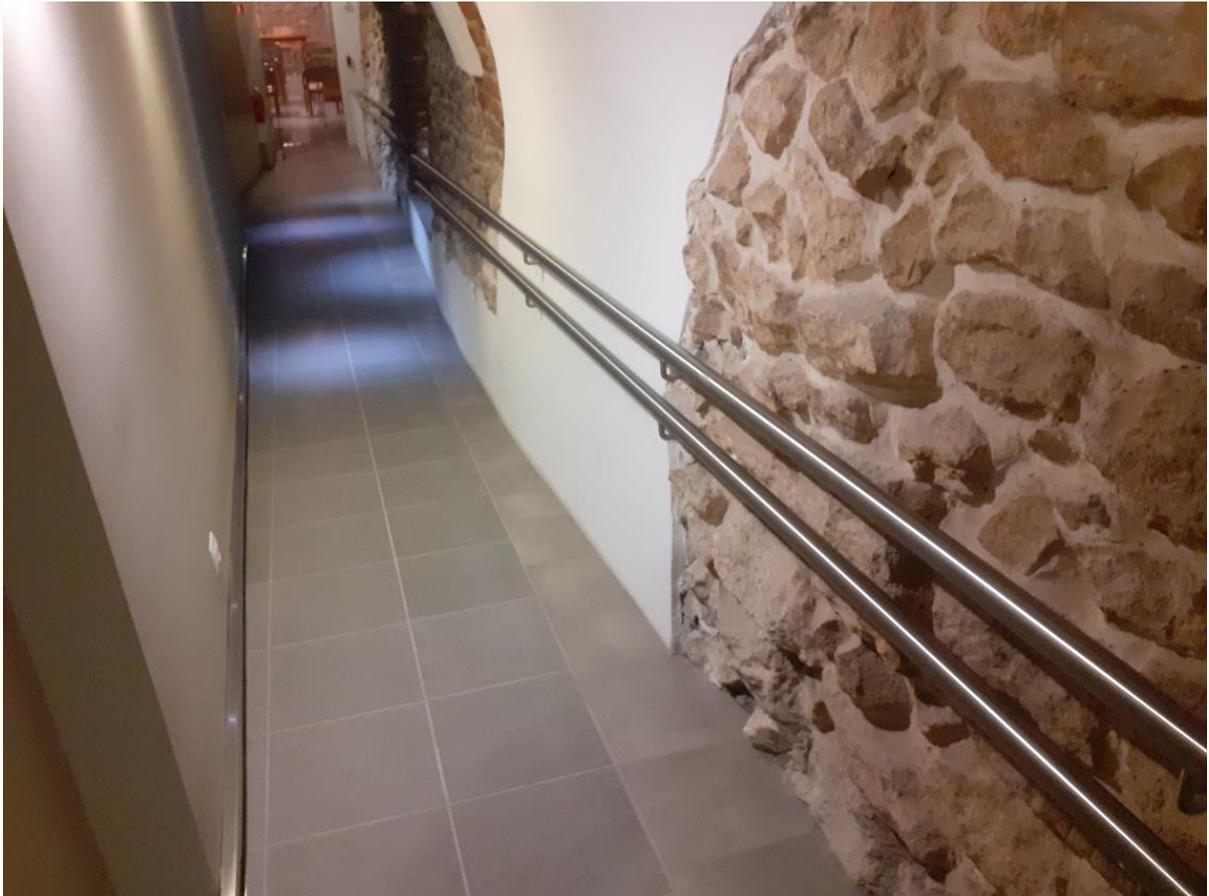
FIG. 35 Corridor connecting the seminar room and the elevator in the basement of the International Cultural Center

The adaptation of cellars that were built at different times was a difficult task, also due to the differences in levels. In order to ensure communication between the elevator and the seminar room, the level difference was reduced by arranging a sloped floor in a long corridor. The handrails were installed on the walls.

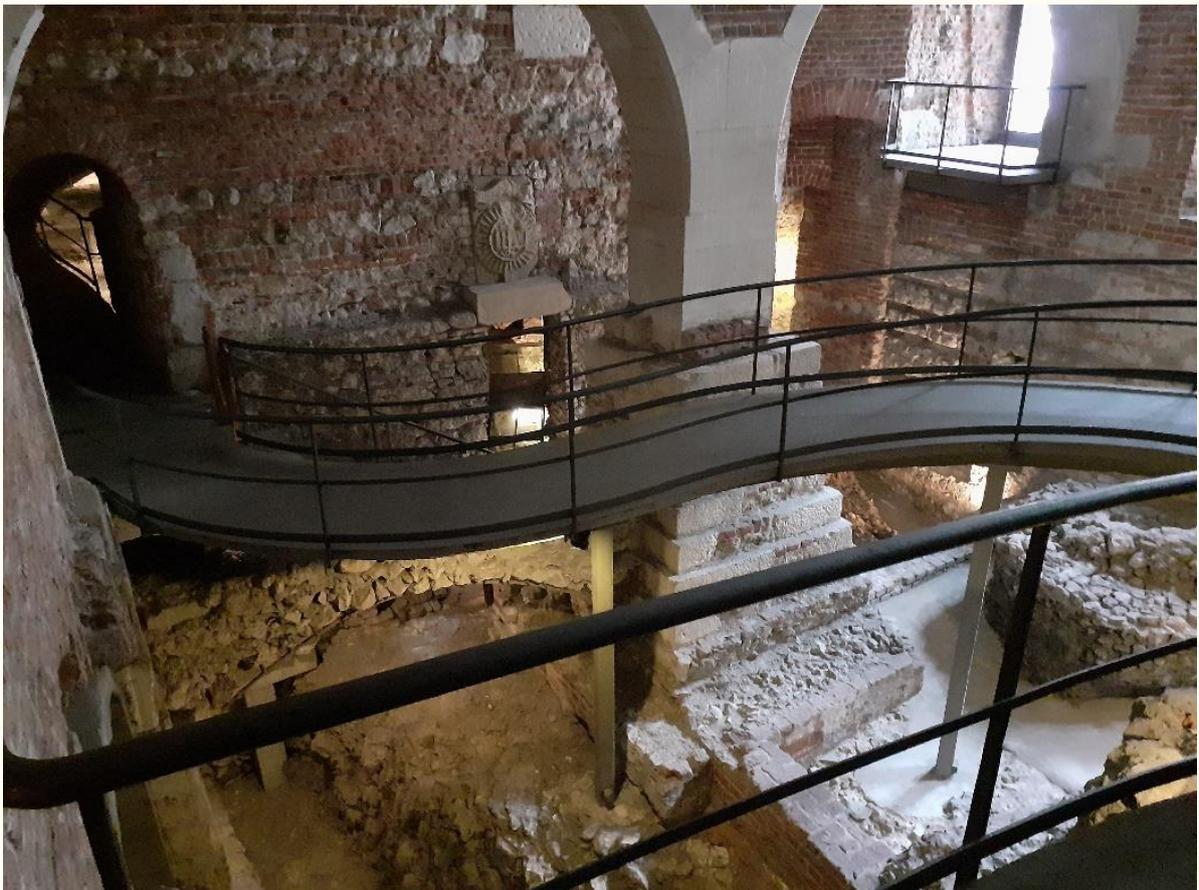
FIG. 36 The concrete platform makes it possible to visit the archaeological reserve, the elements of which are located on many levels

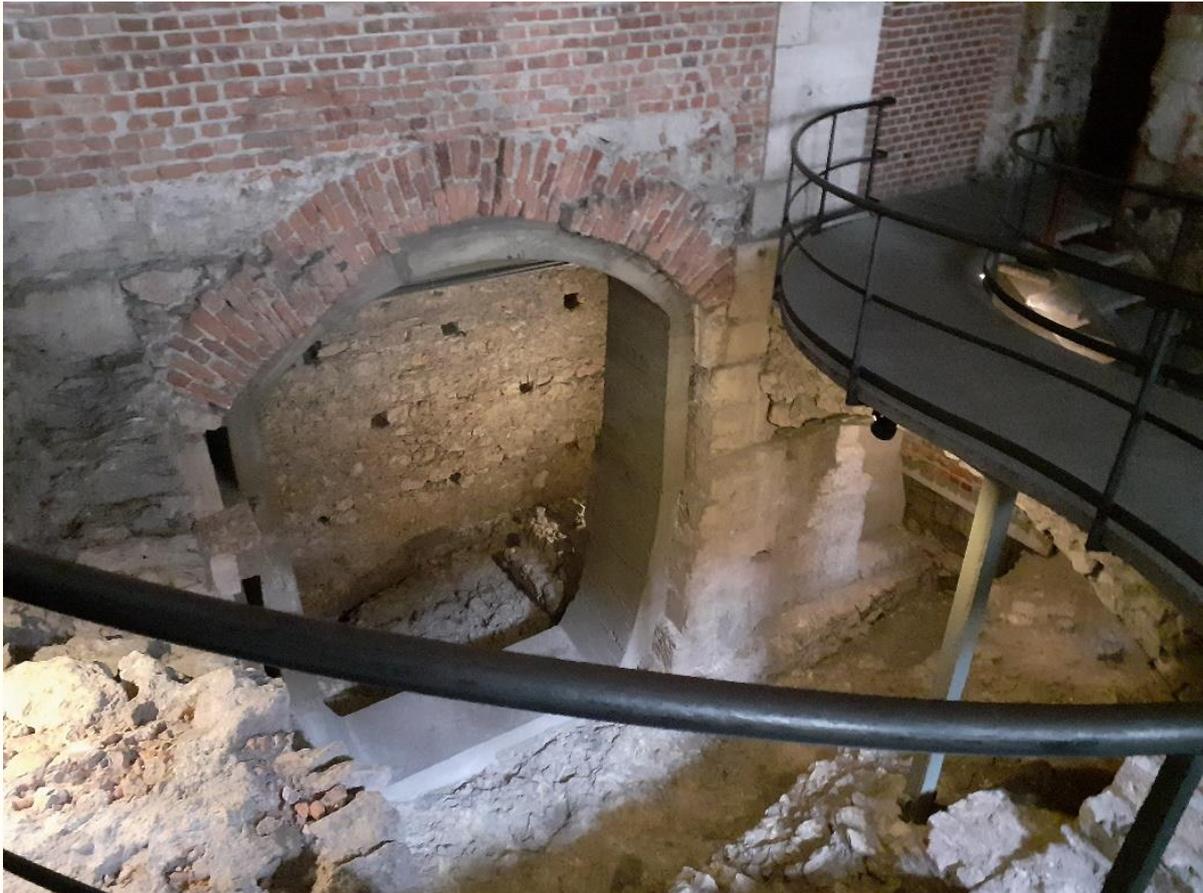
FIG. 37 The platform is placed on slender supports which do not obscure the view of the exhibition

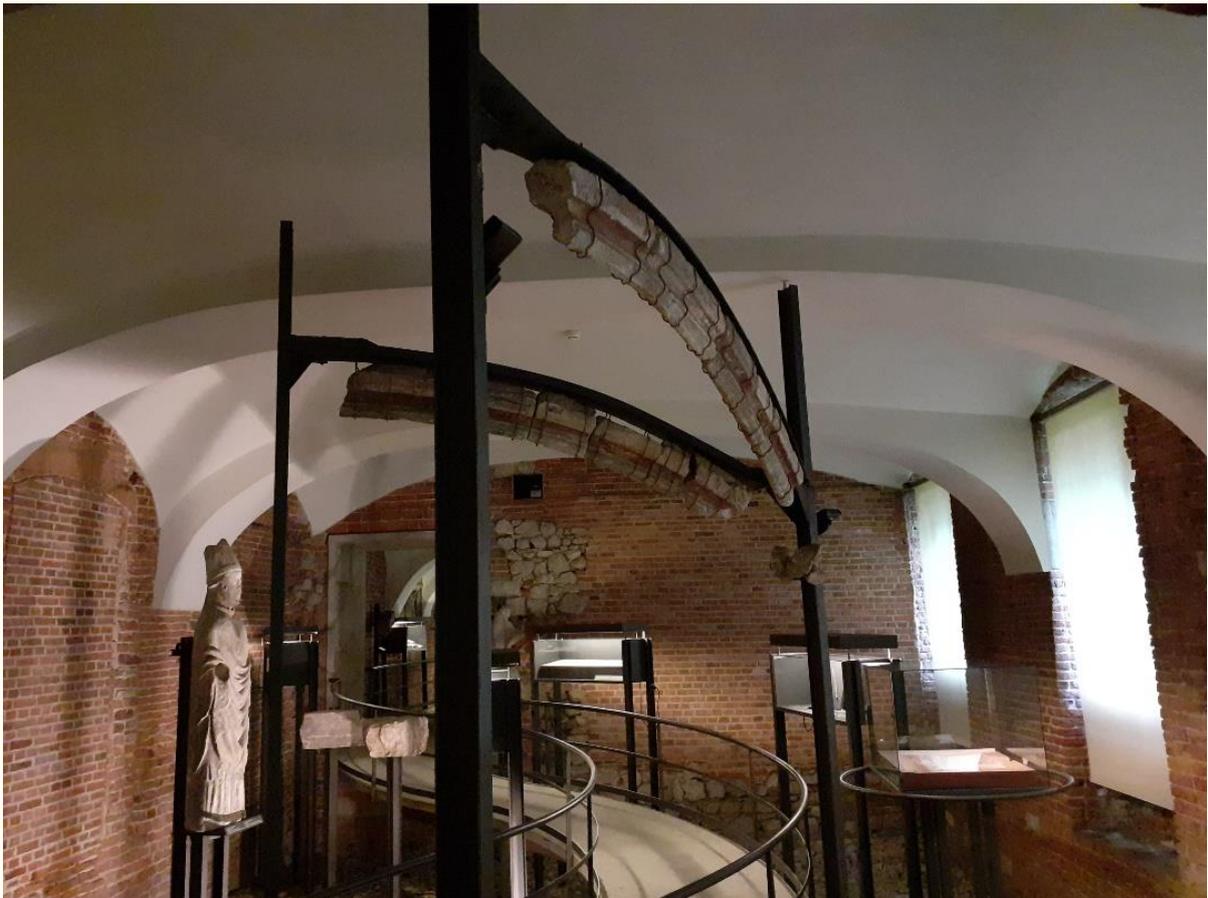
FIG. 38 The platform with the exhibition rooms creates one surface ensuring the accessibility of the entire exhibition
