Adaptation of historic buildings for disabled people

Project UNINET: University Network for Cultural Heritage – Integrated Protection, Management and Use

Lublin University of Technology

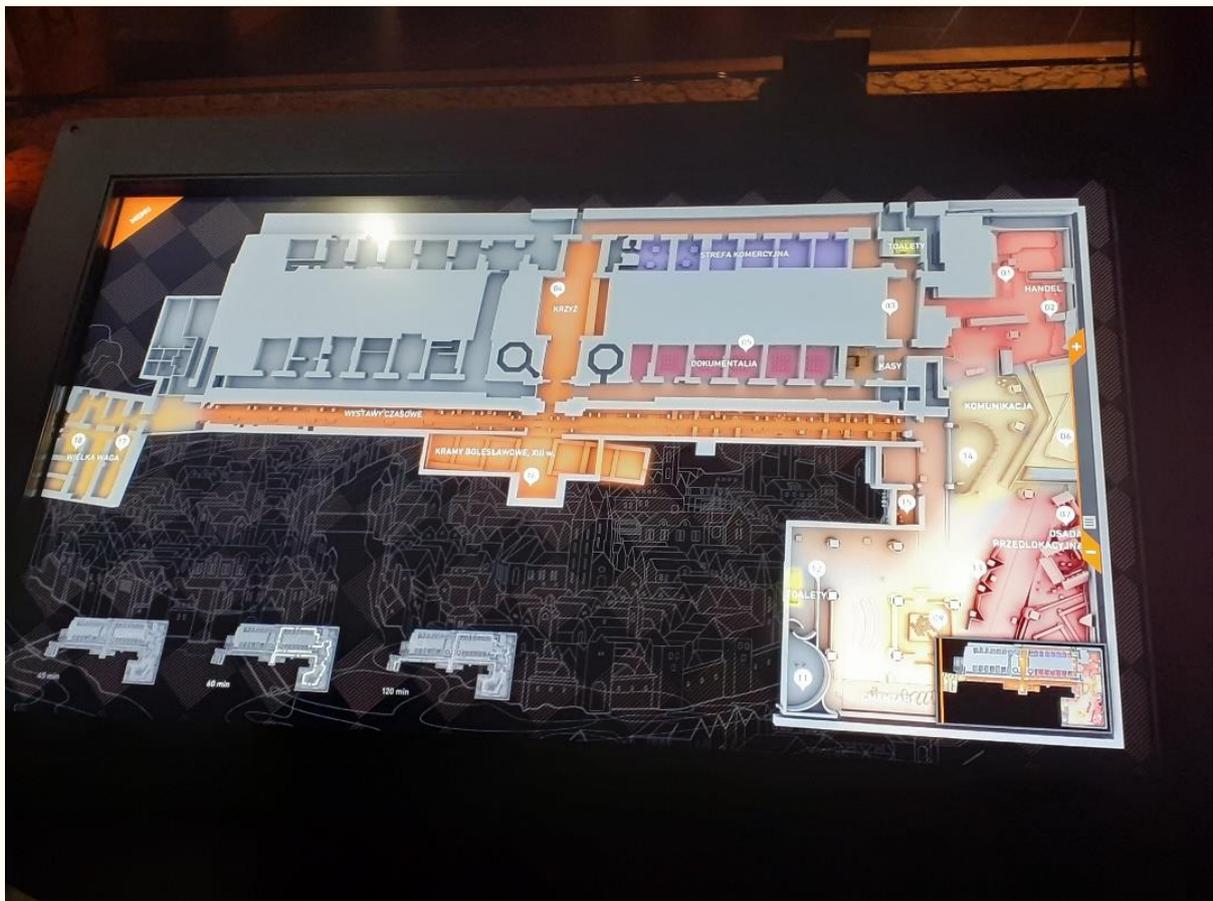
FIG. 39 Plan of the archaeological reserve of the Rynek Underground in Krakow

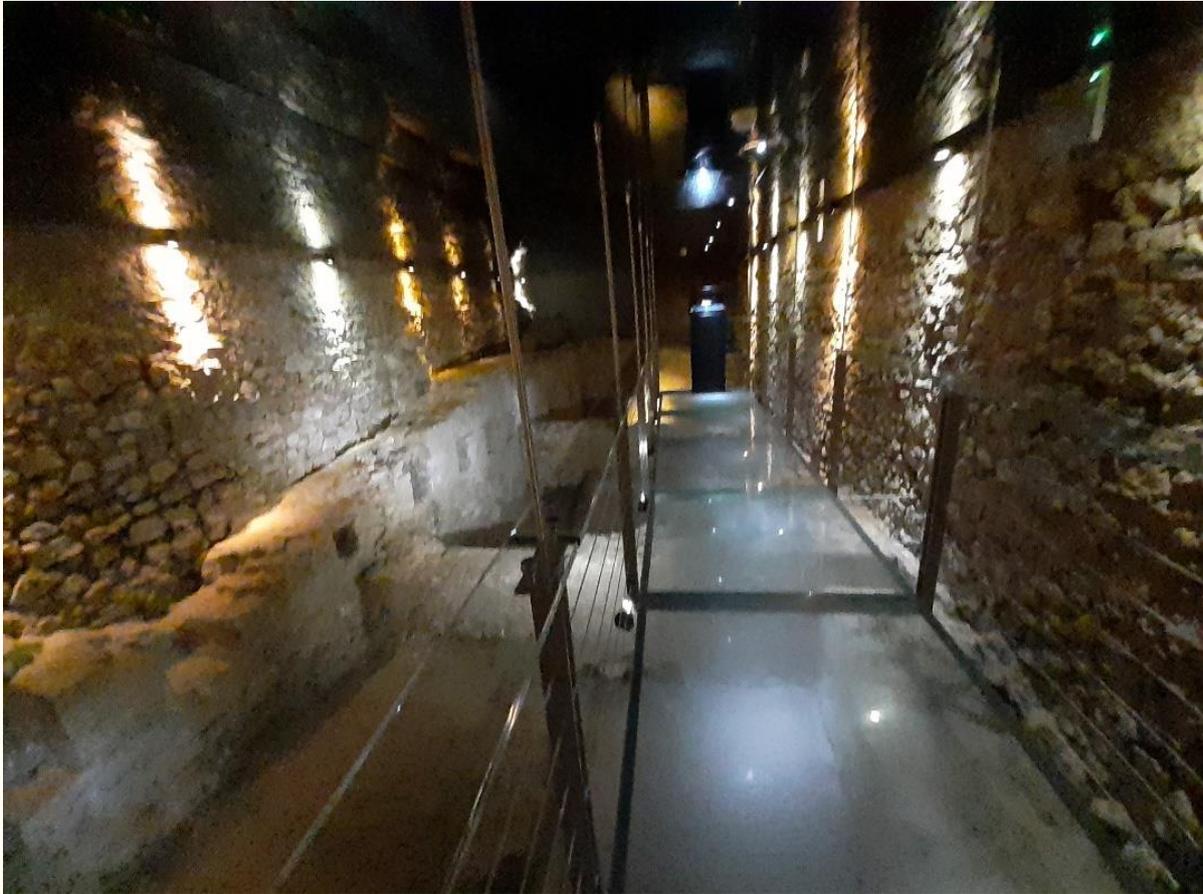
FIG. 40 Glass platforms allow for a detailed presentation of all the elements of the archaeological reserve in Rynek Undergrounds

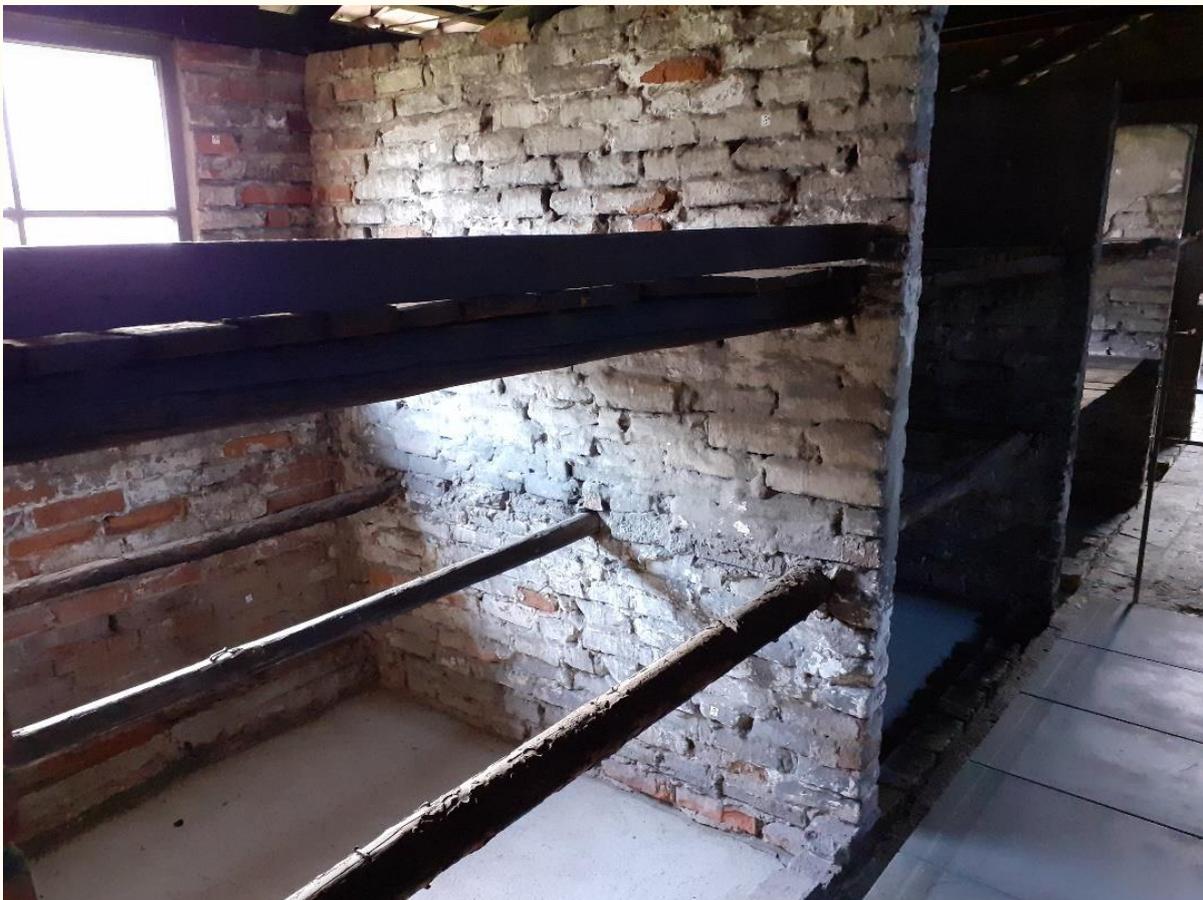
FIG. 41 The barracks in Auschwitz-Birkenau were temporary facilities, carelessly made of low-quality materials

An example of a floor that protects an authentic monument and at the same time forms an uniform level is barracks no. 14 in the former Nazi concentration camp Auschwitz-Birkenau. The complex of 45 barracks is undergoing extremely careful conservation work. It is a very difficult job, because the barracks have been built almost 80 years ago as temporary facilities, made carelessly. However, from the point of view of historical, scientific and emotional value, the barracks are very valuable monuments. That is why they are subject to costly and long-term conservation works.

The barracks are open to visitors. The small spaces in the barracks make it easy to damage the authentic finishing elements when a group of visitors enters. In addition, concrete and brick floors are uneven. Therefore, a raised floor system was set up above the real floor. It protects the authentic surface and creates a surface which facilitates movement . Thus, the system of raised floors can secure the monument while ensuring its accessibility.

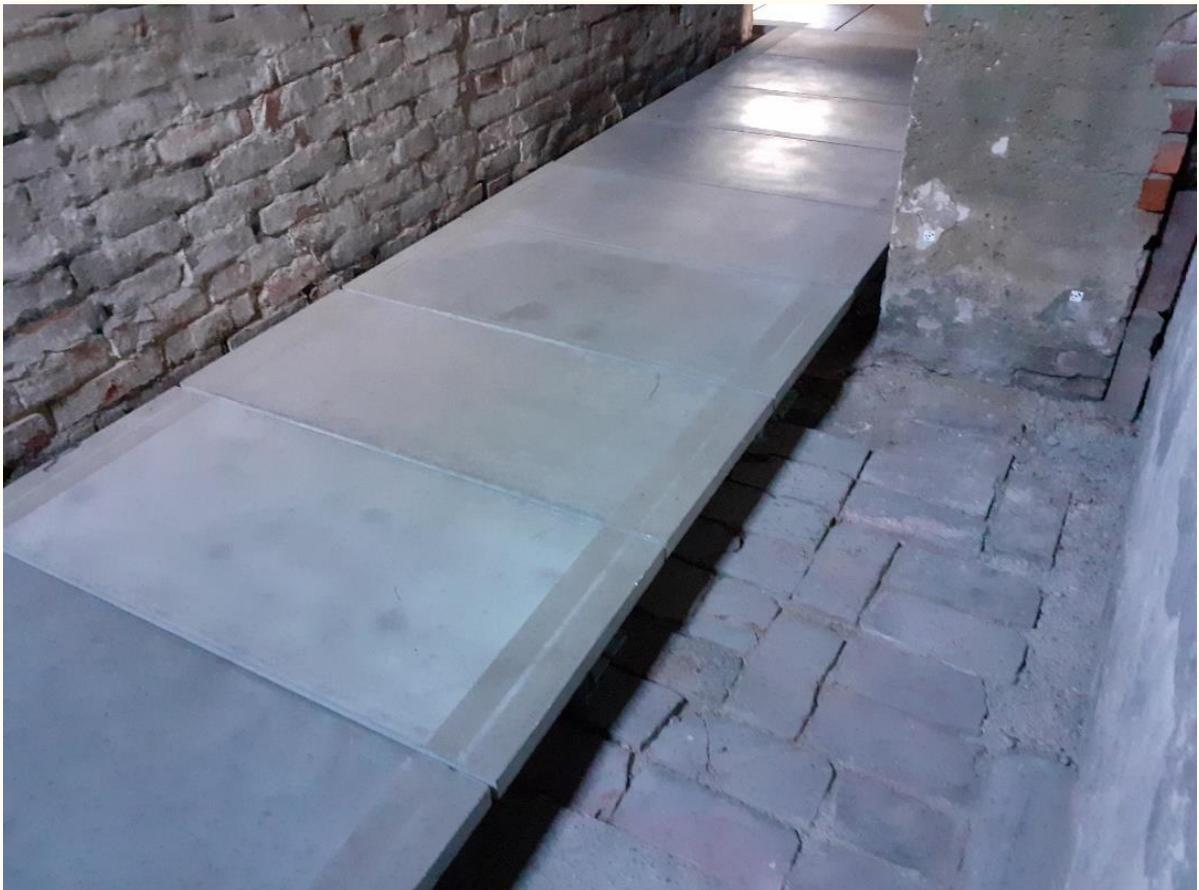
FIG. 42 The raised floor allows the protection of an authentic monument and ensuring accessibility at the same time

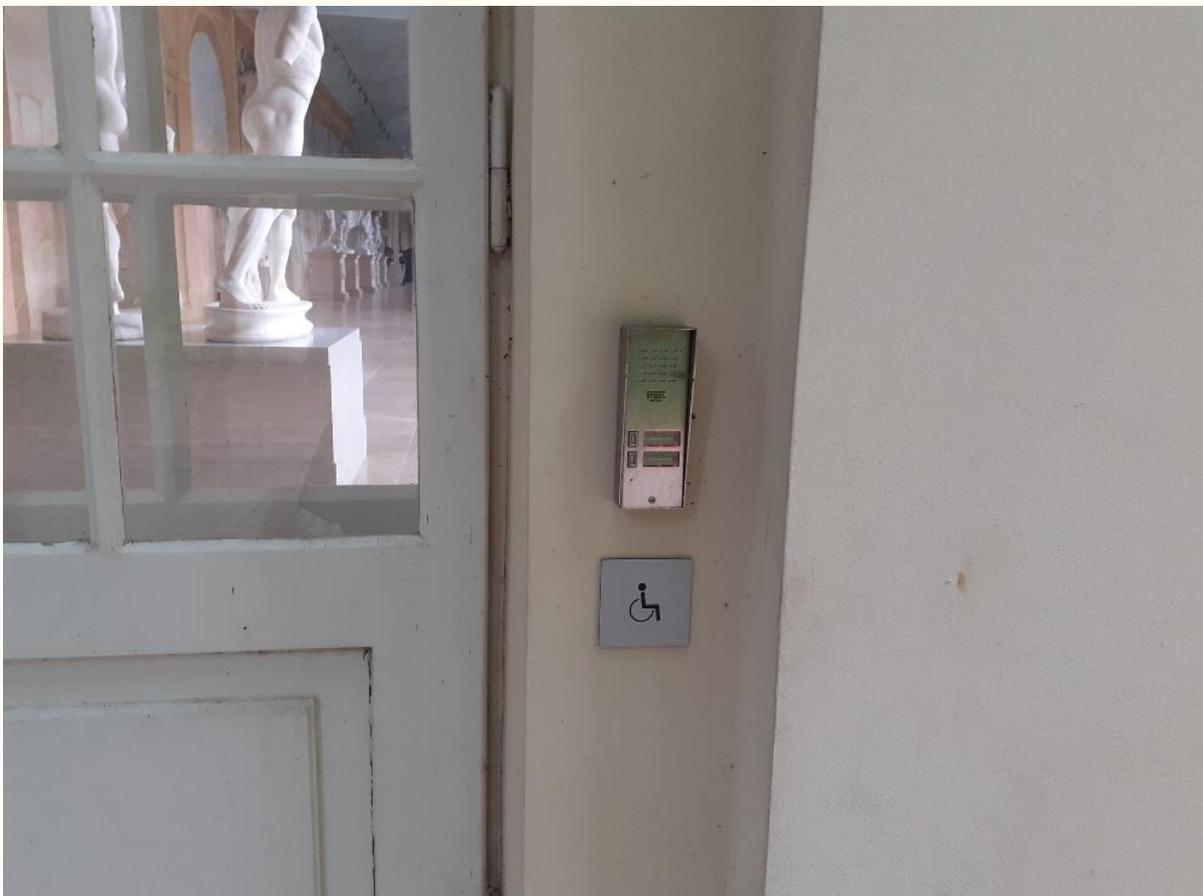
FIG. 43 Panel for notifying the facility staff about the need to open the entrance to the gallery

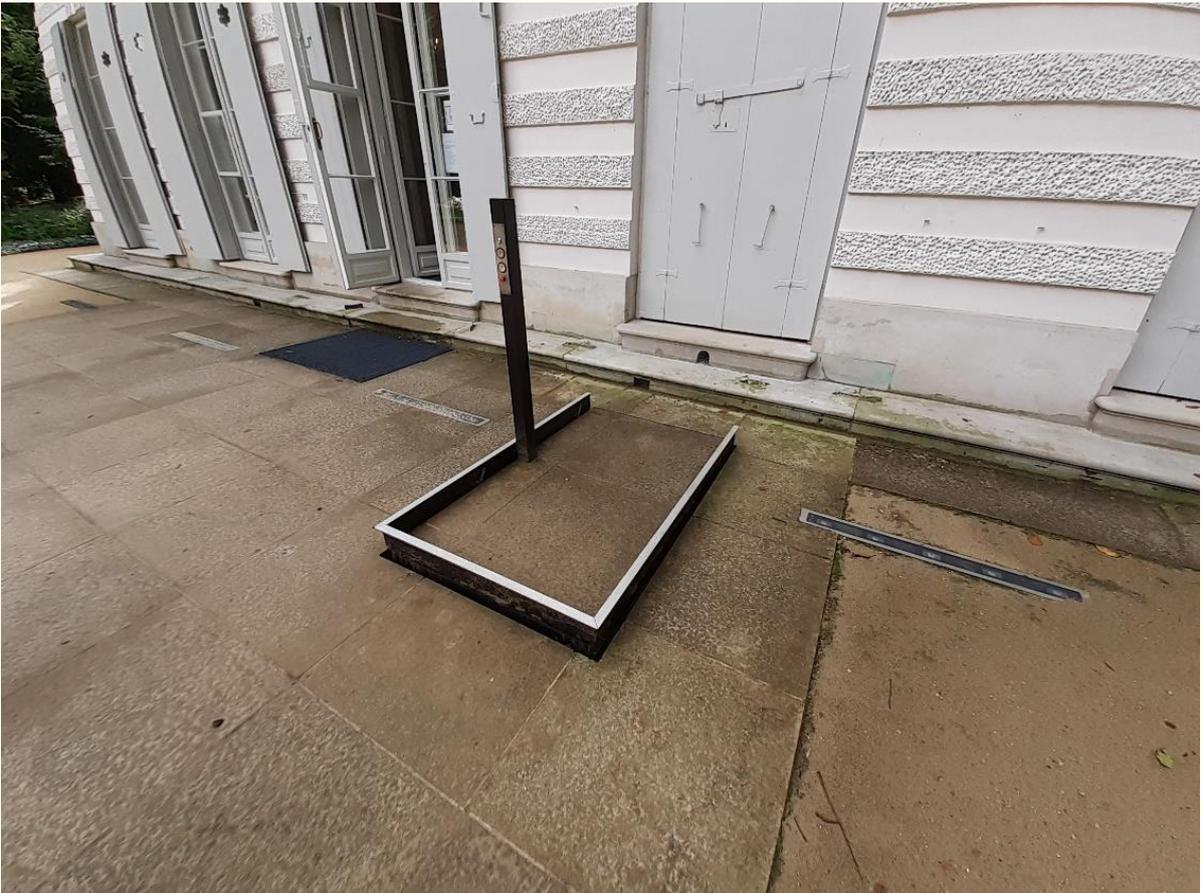
FIG. 44 The microphone for communication with the facility staff was installed in a free-standing element

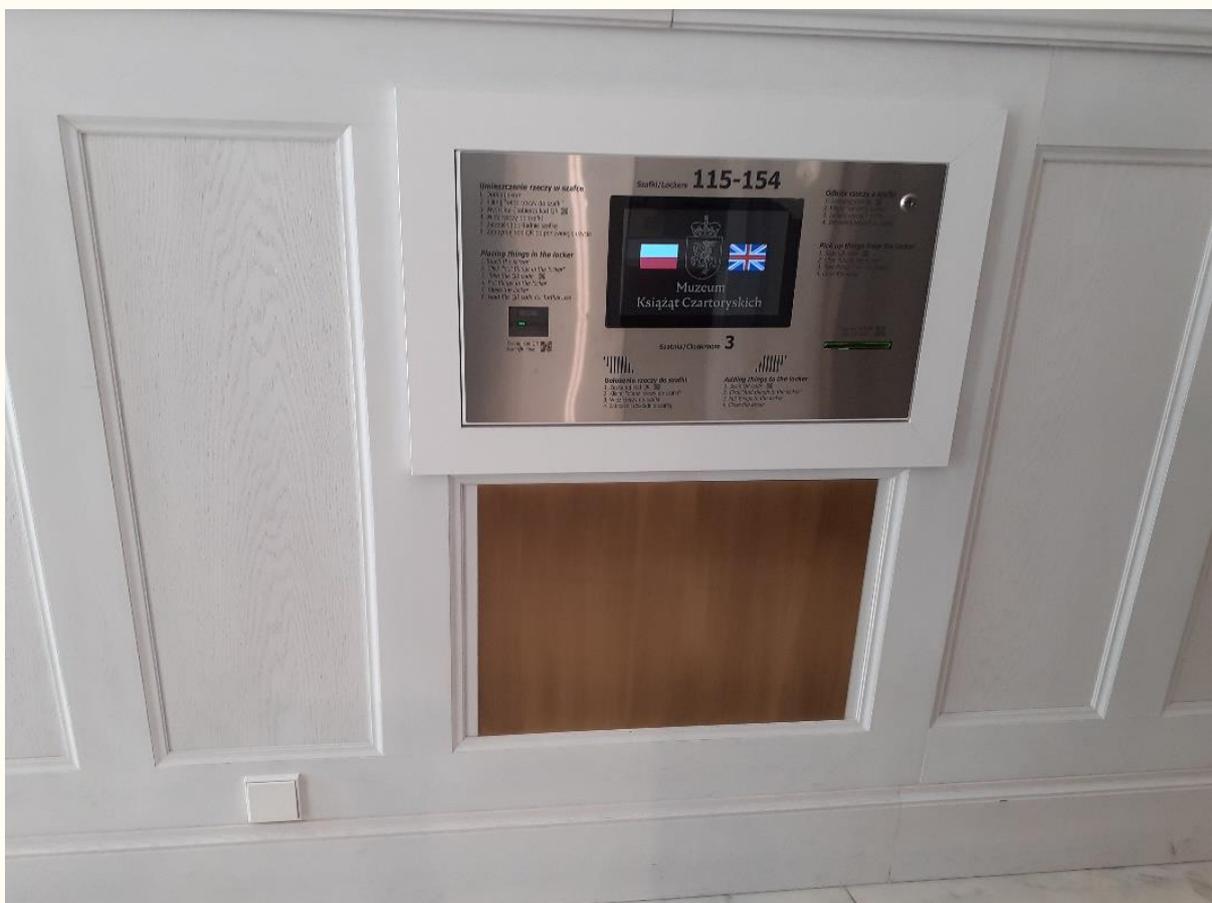
FIG. 45 The control panel for luggage lockers in the Czartoryski Museum was placed at a height convenient for a wheelchair user

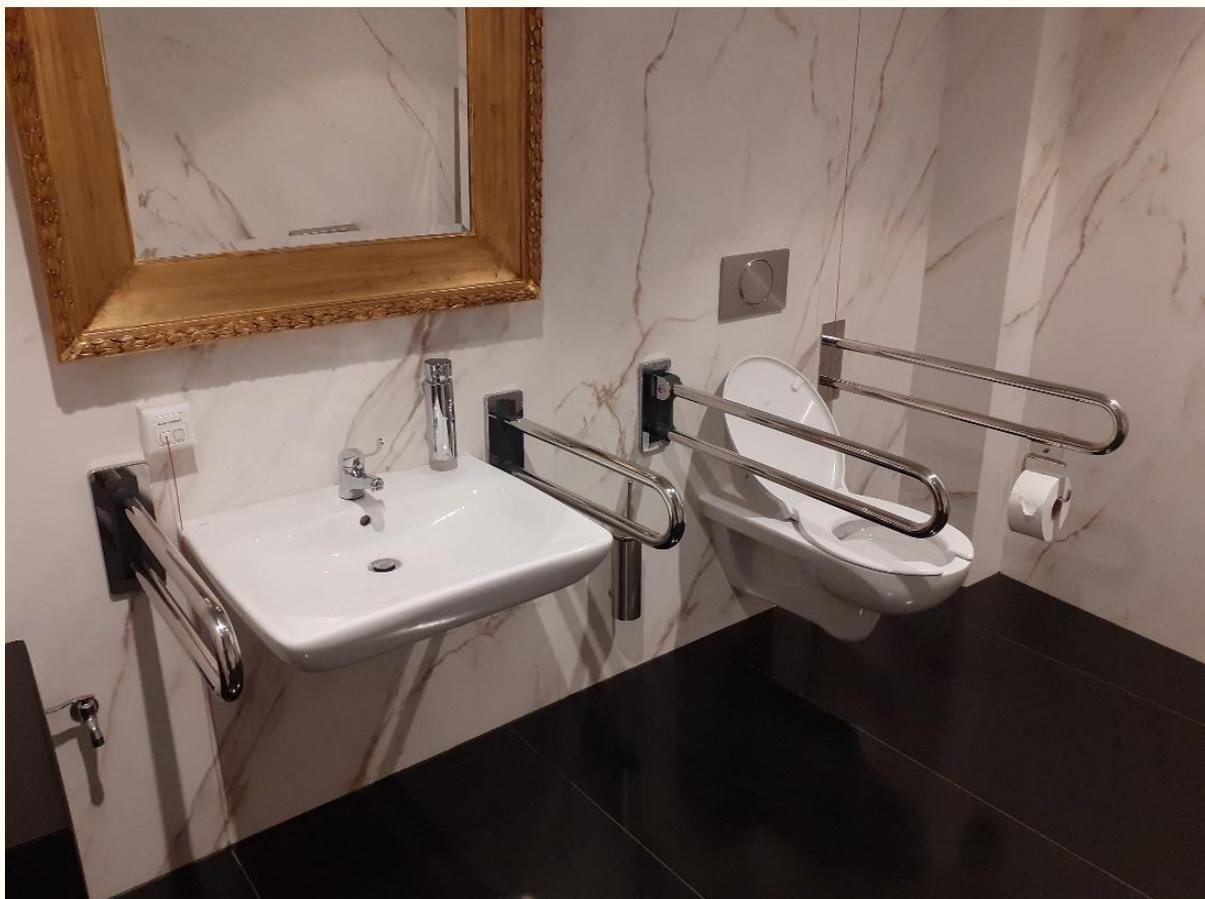
FIG. 47 The toilets in the Czartoryski Museum are of an appropriate size, and the sanitary facilities are equipped with handrails

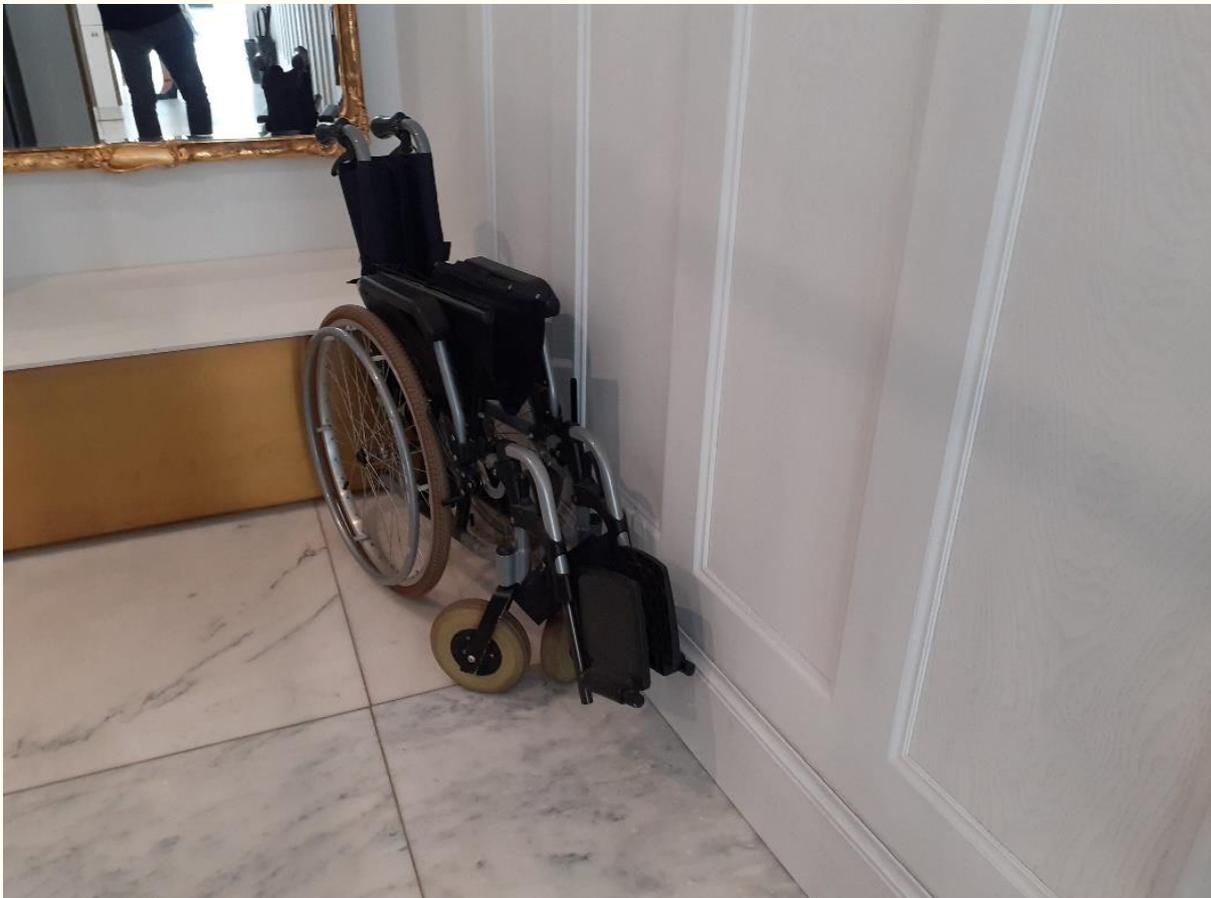
FIG. 48 A wheelchair in a luggage locker room - Czartoryski Museum

The Czartoryski Museum in Krakow is equipped with wheelchairs that can be used while visiting the exhibition and the historic building. The wheelchairs are placed in the tourist luggage locker room at the entrance to the facility at the beginning of the tour. Thanks to this, tourists can immediately see that they can take advantage of this facility. The museum route is free of barriers limiting passage. The building is equipped with an elevator with a door that is wide enough to allow easy maneuvering of the wheelchair.

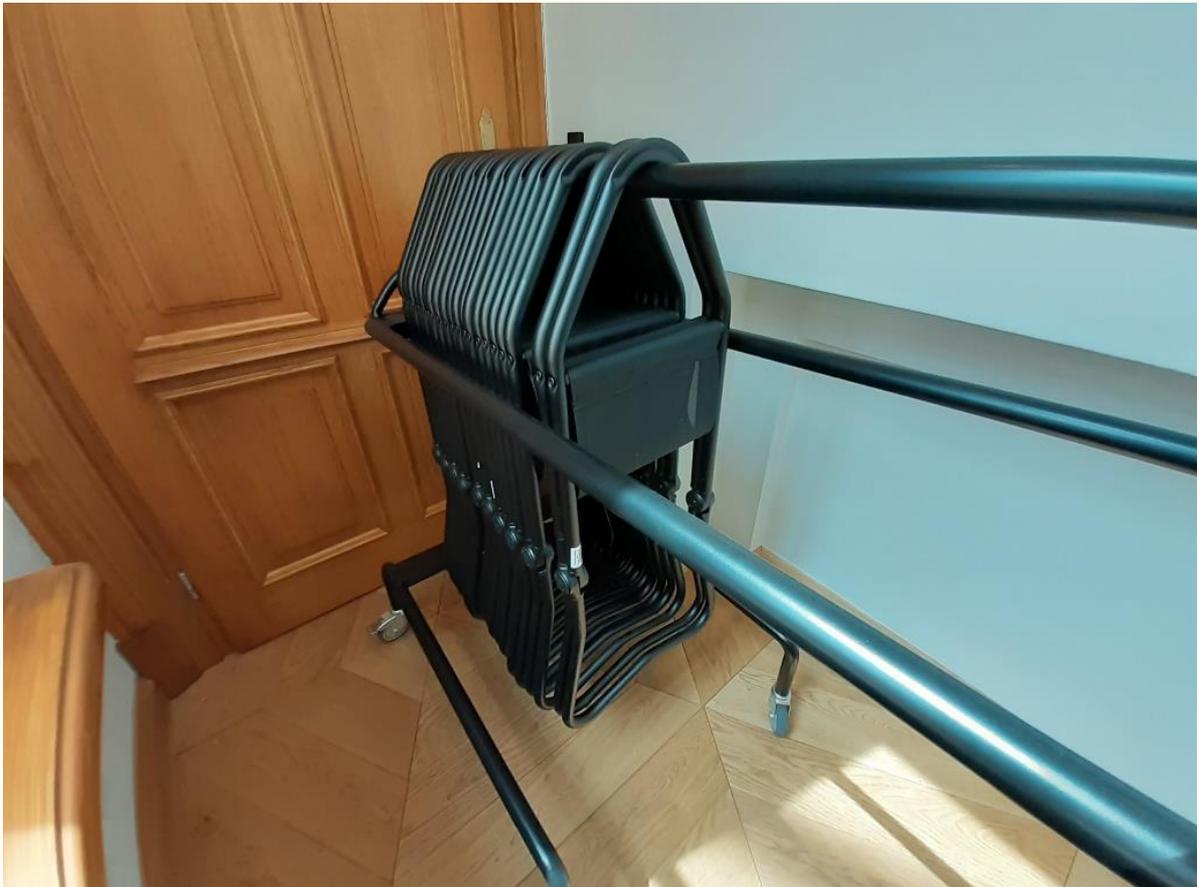
FIG. 49 The stands with chairs are movable and do not take up much space - Czartoryski Museum

Folding chairs have been stored in several places in the Czartoryski Museum. They are located close to the route of the exhibition, so they can be easily used. Chairs are stored on movable stands so they don't take up much space and are easy to transport.

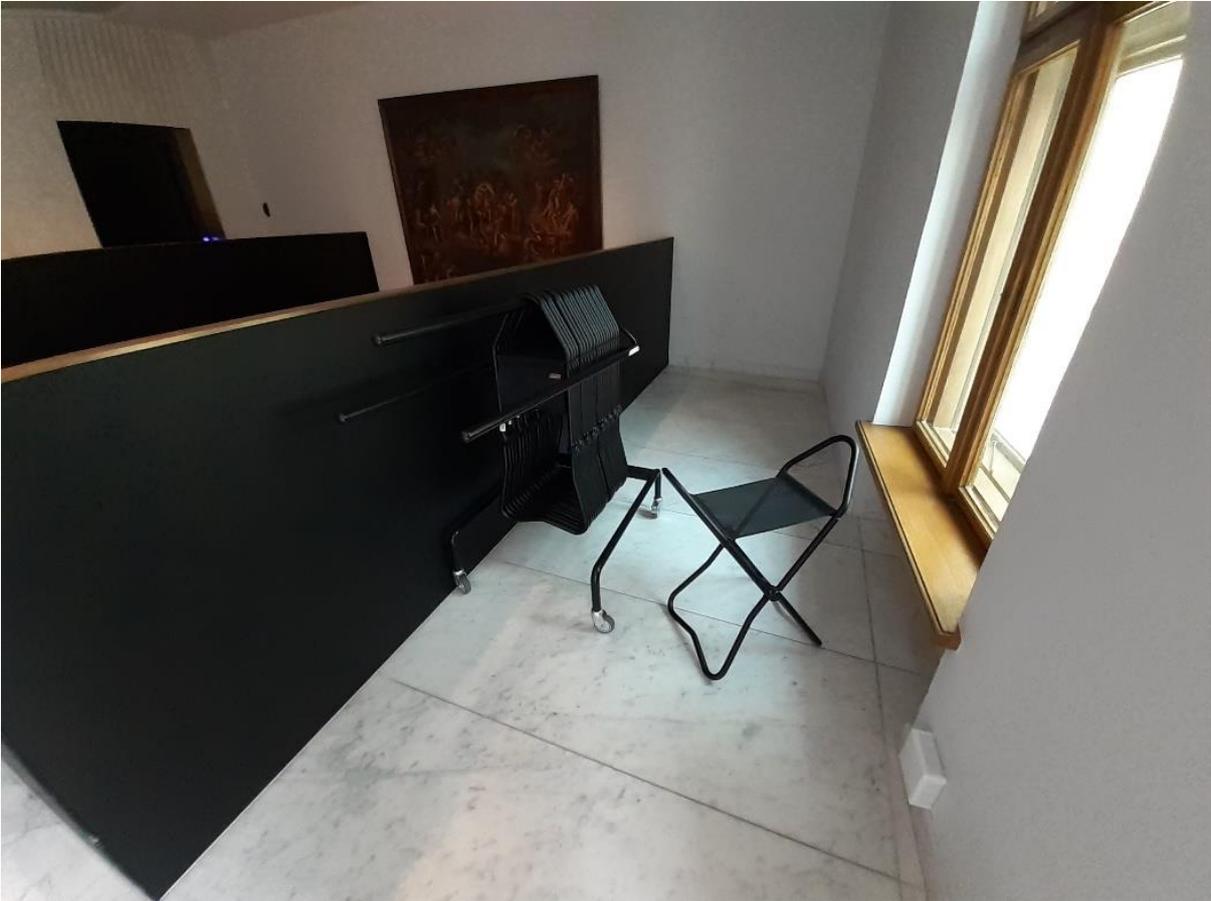
FIG. 50 Chairs placed on the exhibition route in the Czartoryski Museum

Single chairs are placed in different places of the exhibition so person can use them.

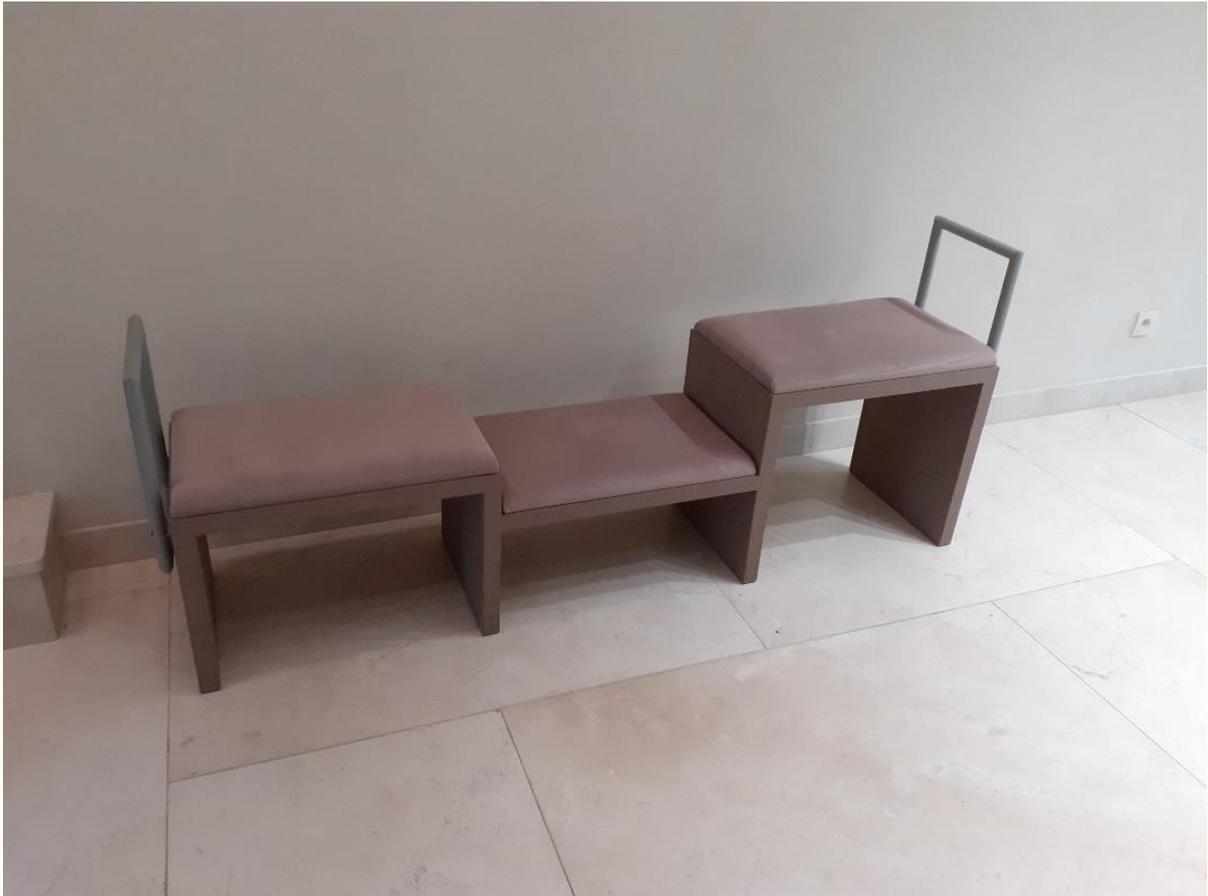
FIG. 51 Benches with seats of different heights - Czartoryski Museum
